SISTERS OF MERCY CONVENT, BALLINA, CO. MAYO

**ARCHITECTURAL HERITAGE IMPACT ASSESSMENT and
CONSERVATION REPORT**

REVISION A - ADDENDUM ADDED - JULY 2024

**ADDENDUM - JULY 2024: TENDER FOR HISTORIC STRUCTURES FUND (HSF)
WORKS: SPECIFICATION AND DRAWINGS**

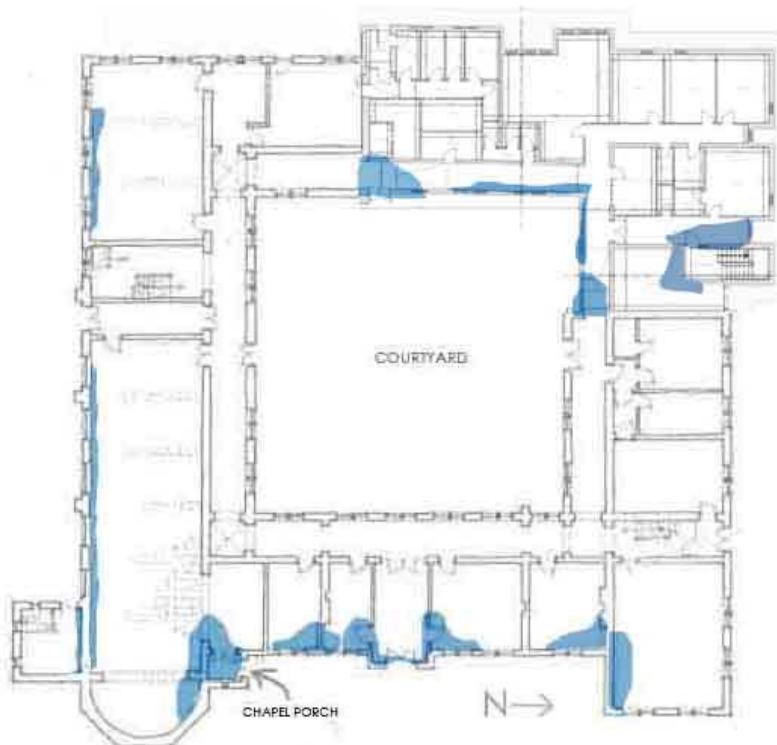
GROUND FLOOR PLAN

Details of existing cast-iron rainwater gear and plans of building below (using plans from *Martin Henihan Thesis*), with areas of existing severe water ingress shown blue.

■ SEVERE WATER INGRESS

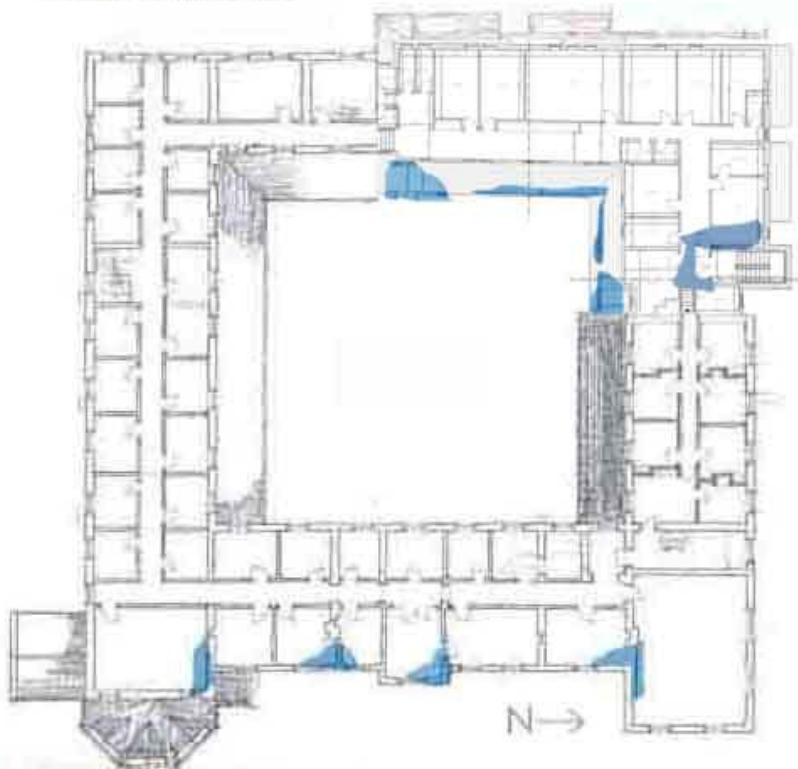
FIRST FLOOR PLAN

■ SEVERE WATER INGRESS

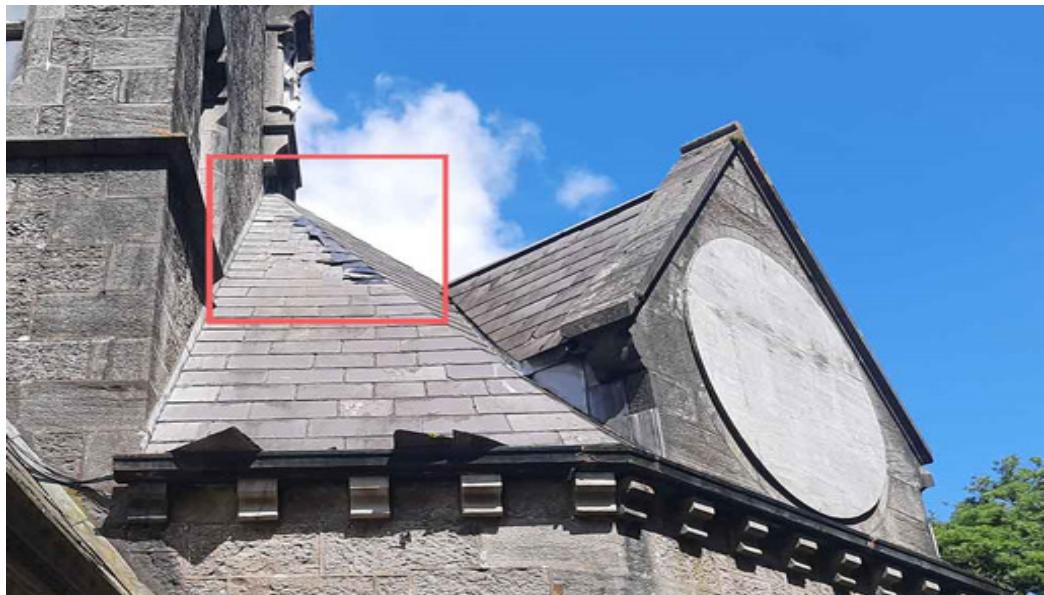
Approximately 20 no. missing/broken slates are evident on the south section of the apse roof. The affected section requires slate removal of adjacent slates and to the top of the roof; removal of existing battens; removal of existing felt layer; refixing of a new section of breathable felt, with new treated sw battens to match the existing over. Replacement slates to match the existing in size and provenance, colour, texture and thickness should be sourced. Some local reputable sources may provide similar slates as is likely due to the small amount required. It is also possible to source the original slate quarry and have new slate made up for the purpose, but this may not be necessary or feasible.

Area of slate loss at chapel apse roof

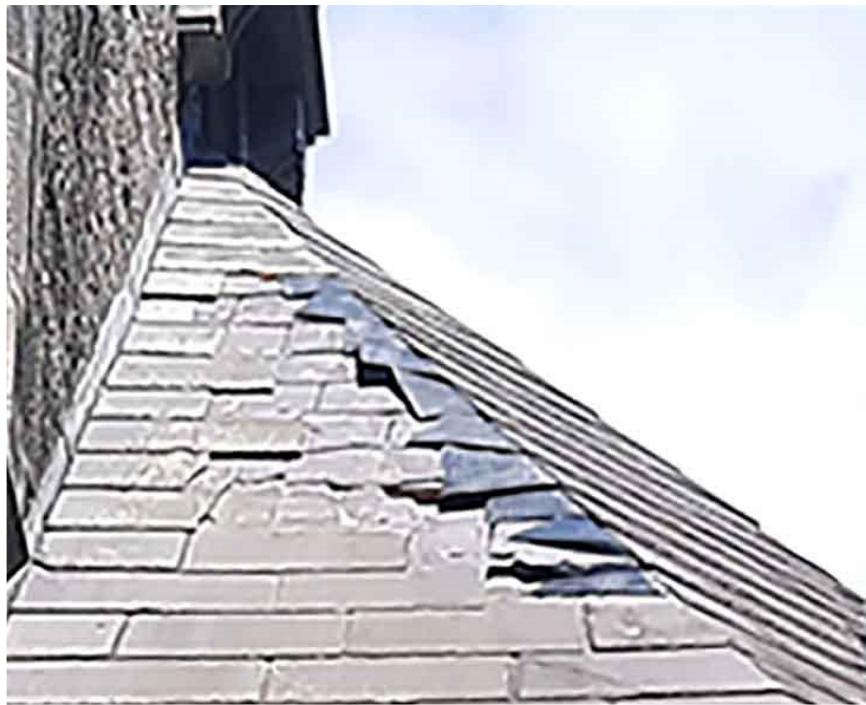
Close-up of slate loss at chapel apse roof

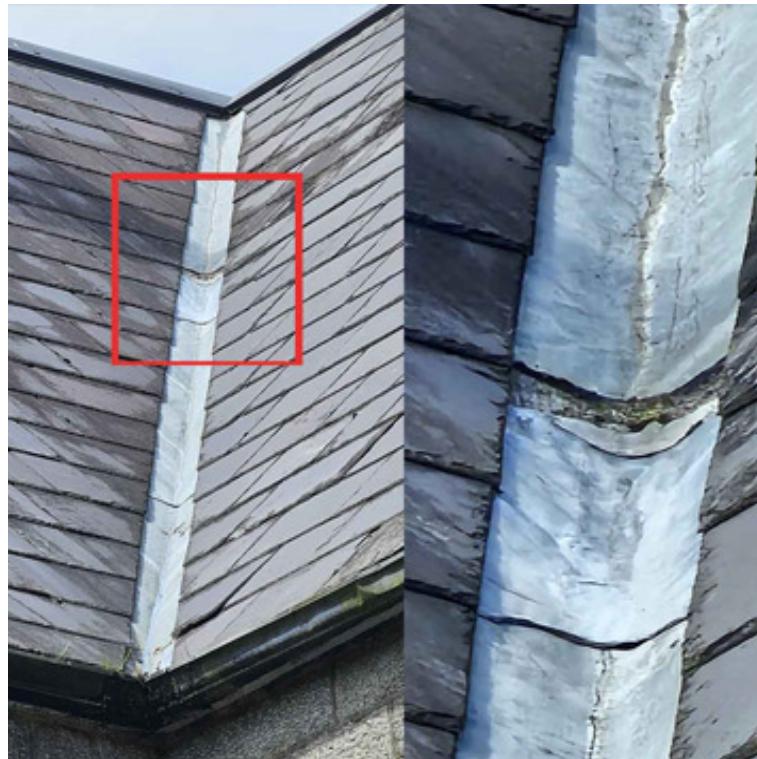
General view and close-up view of slipped valley gutter

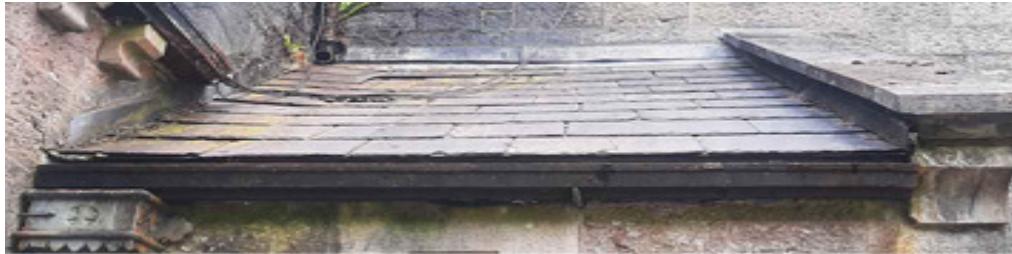
Close-up of damage at Chapel Porch Roof - section of surviving historic gutter also shown

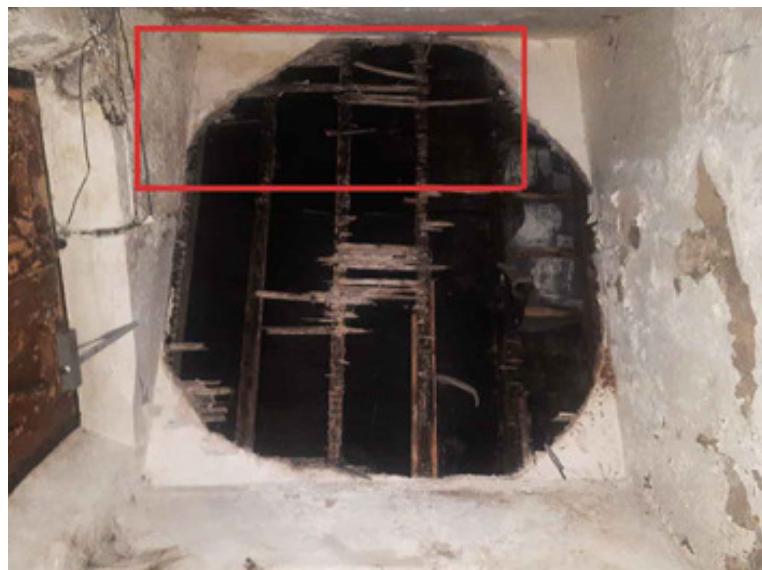
Underside (ceiling) of Chapel Porch Roof – showing rafter ends to be repaired

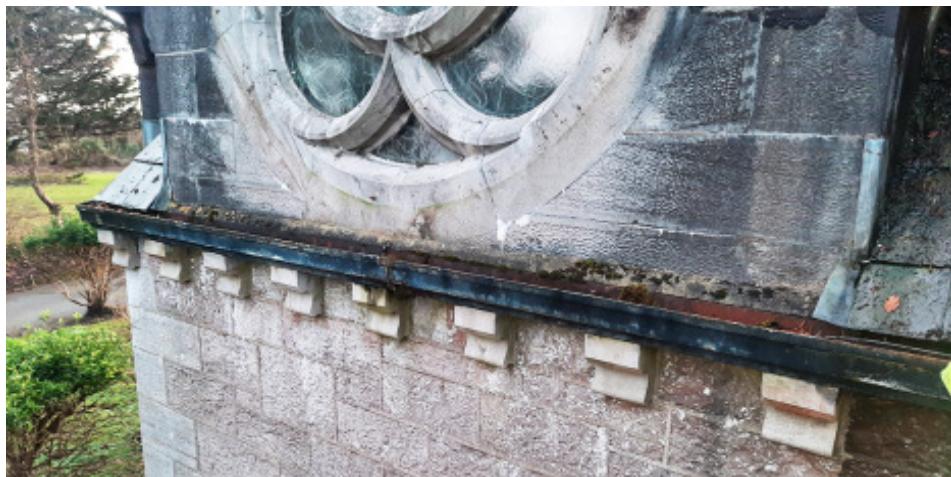
Surviving section of historical gutter at chapel apse

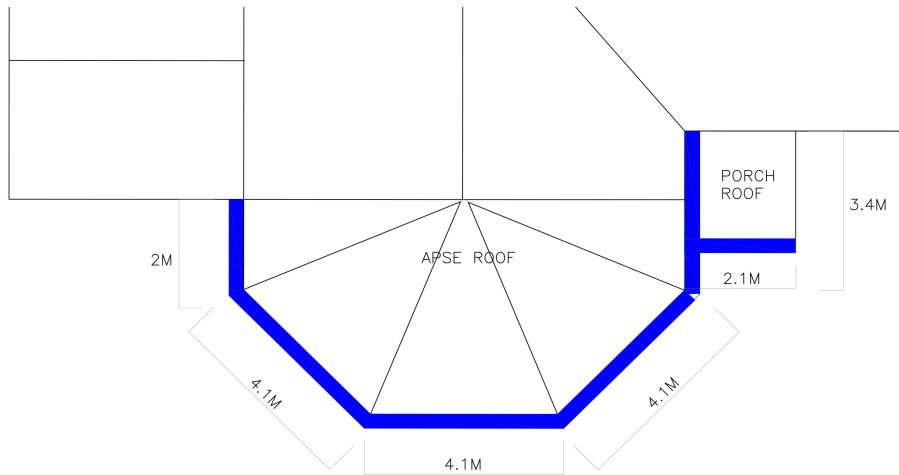
Surviving historical gutters at chapel apse and chapel porch

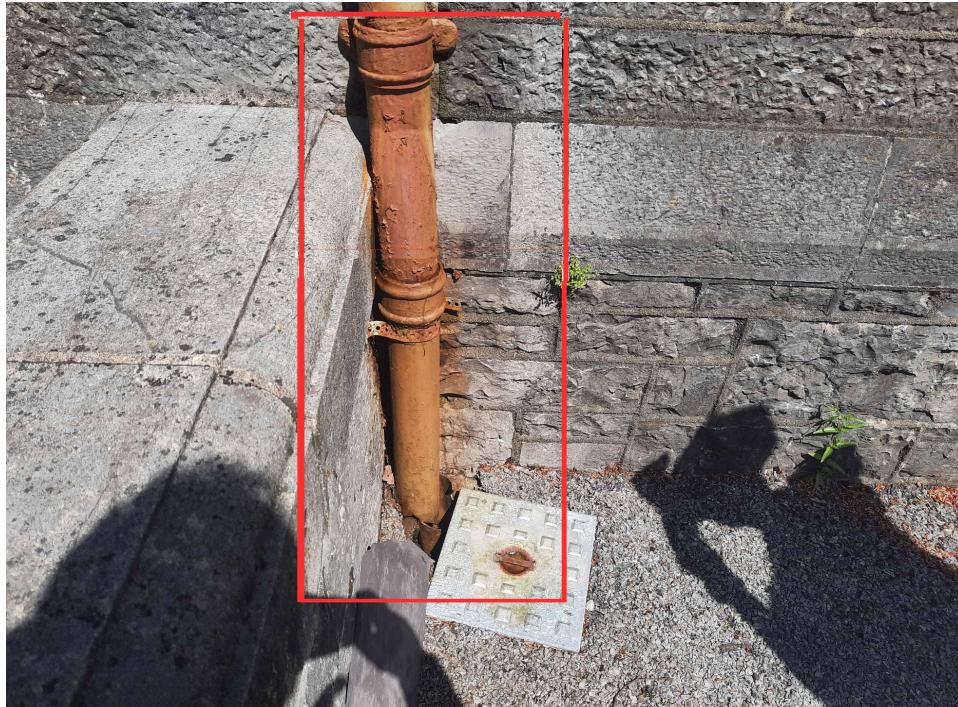
Replacement downpipe at RWP 1 - new bend and shoe also required: South elevation

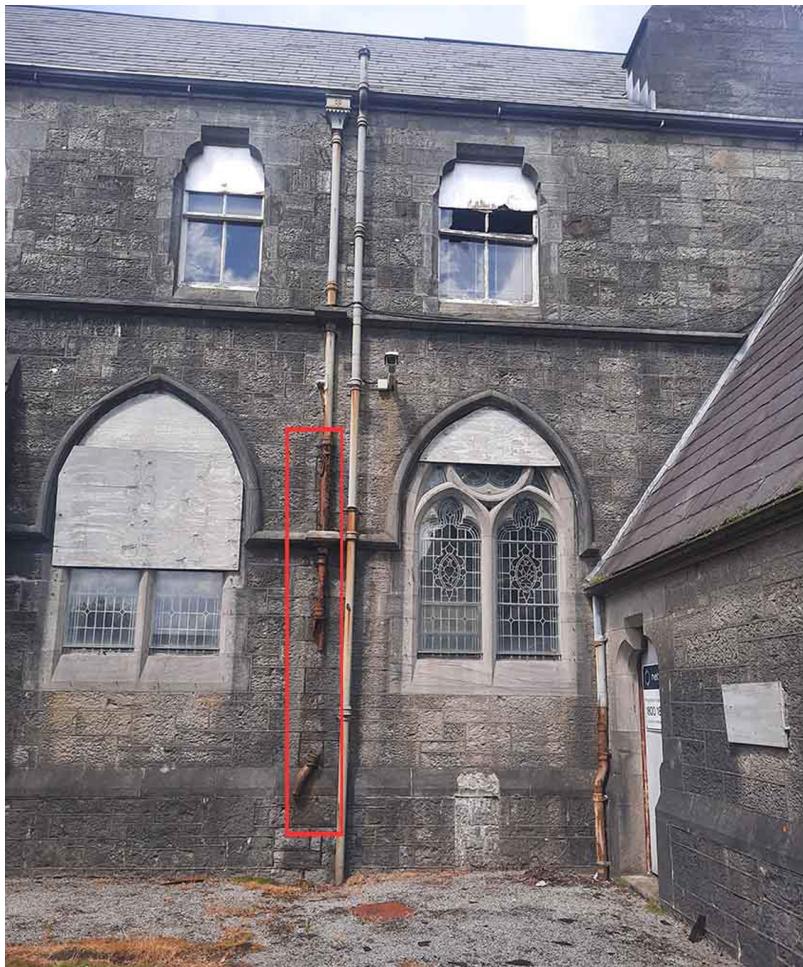
Replacement downpipe at RWP 2 - new bend and shoe required - South elevation

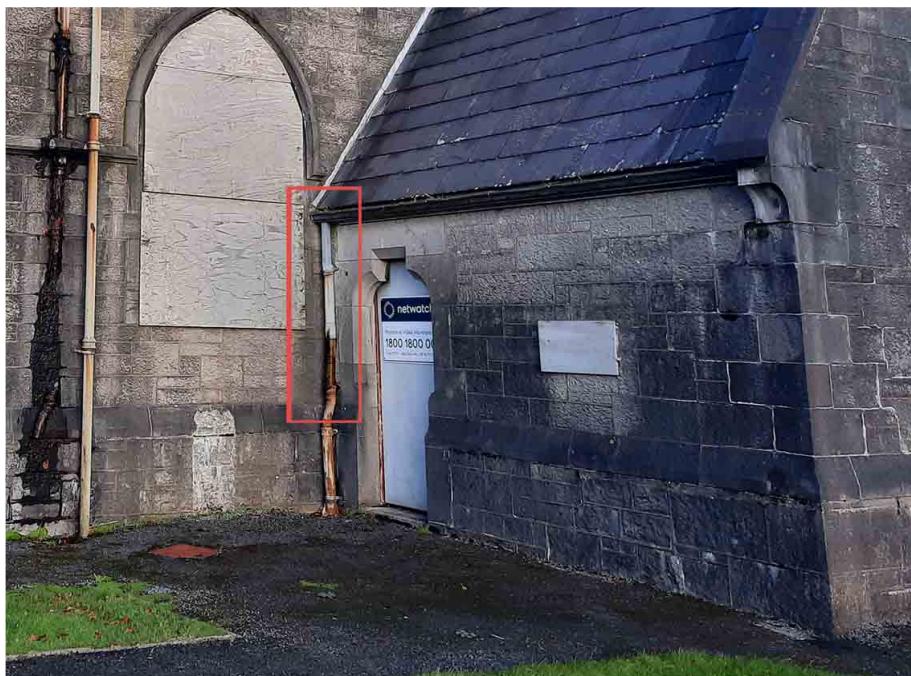
Replacement downpipe at RWP 3 - Sacristy - South elevation

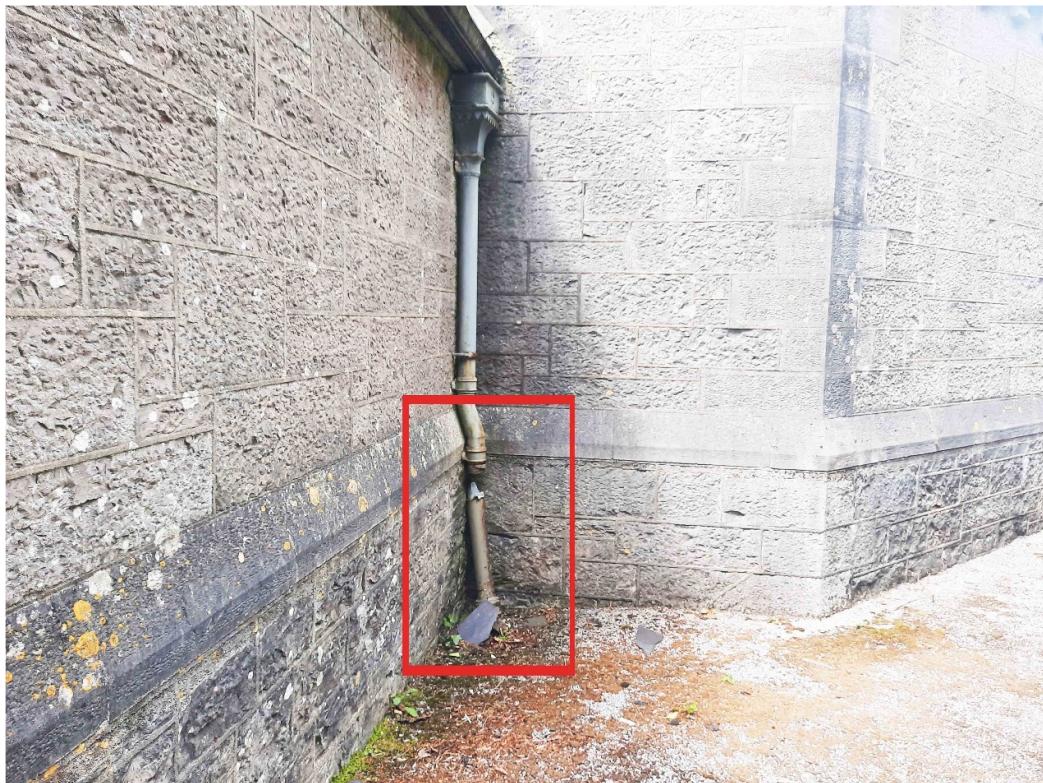
Replacement downpipe at RWP 4 - Sacristy - new shoe also required - South elevation

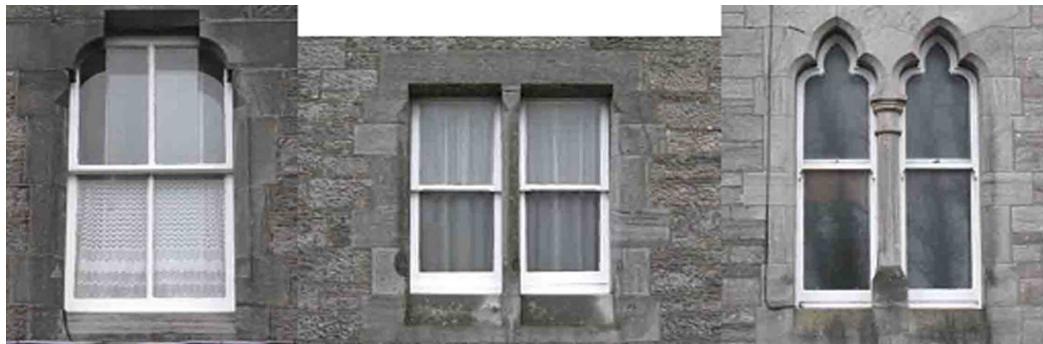
The windows are also affected to varying degrees by ongoing wet rot, denudation of the weight mechanisms and ironmongery. Therefore, the proposals below include conservation-based repairs to the windows, frames, weight mechanisms and ironmongery.

Typical sliding sash windows to be refurbished
