OLD QUAY SCHOOL BALLINA
PETRIFYING SPRING SCRUB CLEARANCE
November 2022

May 2023

Report produced by Denyer Ecology

This work was commissioned by River Moy Search and Rescue Ballina.

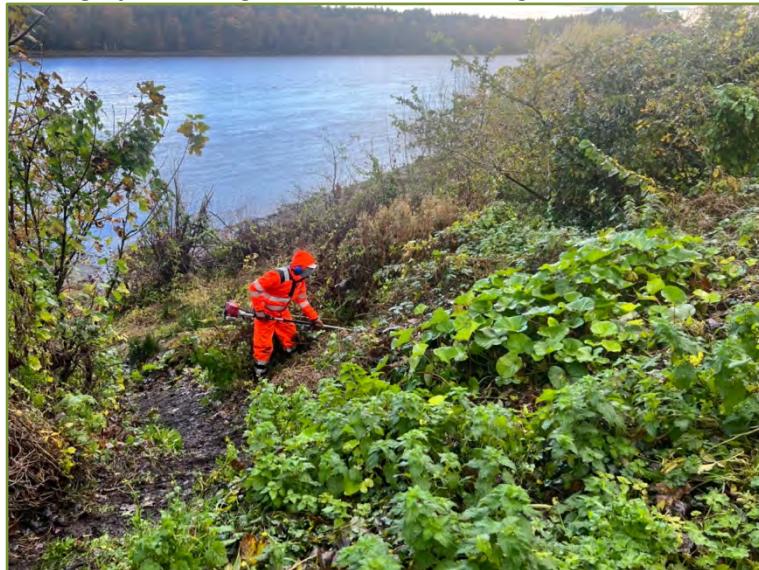
Photograph 2.1. Vegetation clearance using hand strimmer

- The scrub clearance was supervised on site by a petrifying springs ecologist (Dr Joanne Denyer).
- Clearance was undertaken using hand strimmer and chainsaws (where required for woody vegetation) (Photograph 2.1).

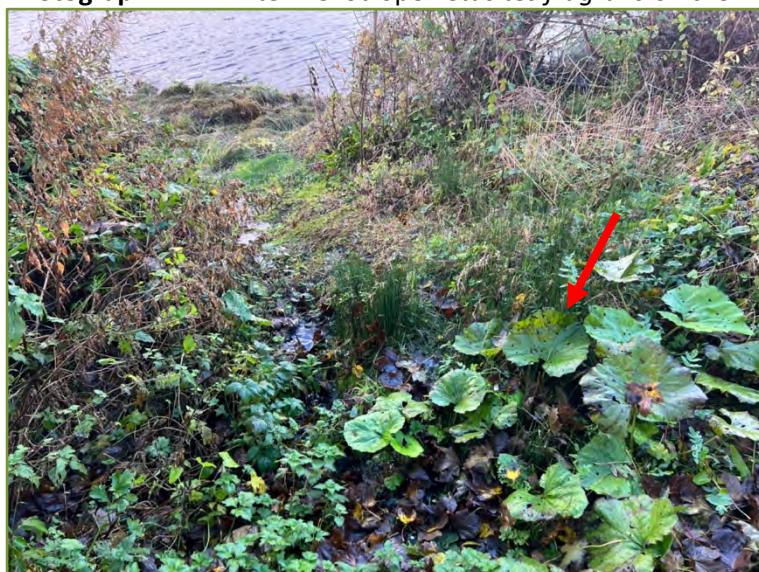
- The invasive plant Winter Heliotrope *Petasites fragrans* is present on the site and on the spring mound (Photograph 2.2). To ensure that there was no spread of this species, areas of Winter Heliotrope were avoided by the contractors. It was not possible to fence these areas as there were several patches of the plant scattered throughout the working area. Before commencement of work, the workers were shown the plant and where it was on site, how to access areas and where not to go. All works were supervised by the project ecologist.

Photograph 2.2. Winter Heliotrope *Petasites fragrans* on the main spring mound

- The access routes, working area and removal of vegetation all avoided Winter Heliotrope areas.
- Where Winter Heliotrope was present on the spring, these areas were not cleared of vegetation to avoid any disturbance to Winter Heliotrope.

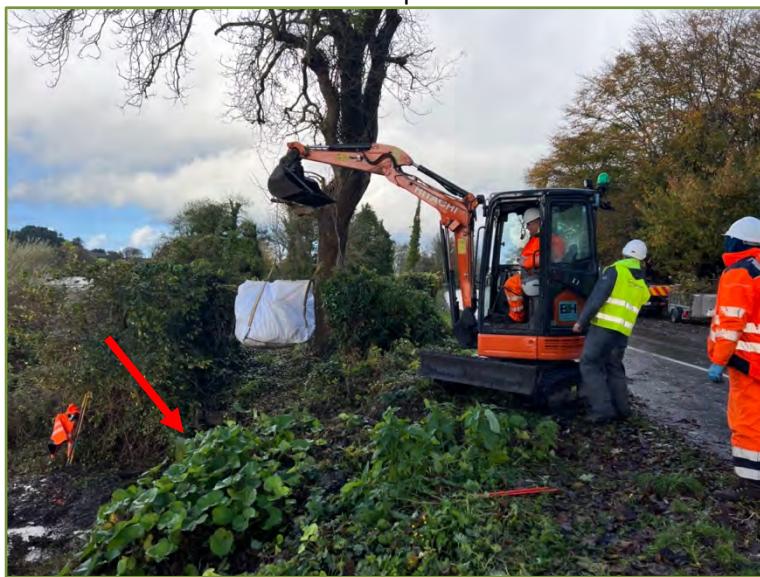
Photograph 2.3. Machinery lifting cleared vegetation (under supervision by the project ecologist). Red arrow shows Winter Heliotrope.

- All vegetation was cleared by hand to avoid the use of machinery around Winter Heliotrope.
- One machine was used to lift the bags of vegetation from the spring into the truck on the road (Photograph 2.3). This was used from the top of the bank. A safe access point on the bank, with no Winter Heliotrope, was identified which was just wide enough for the machinery as

there were frequent scattered plants here. The machinery use was supervised by the project ecologist.

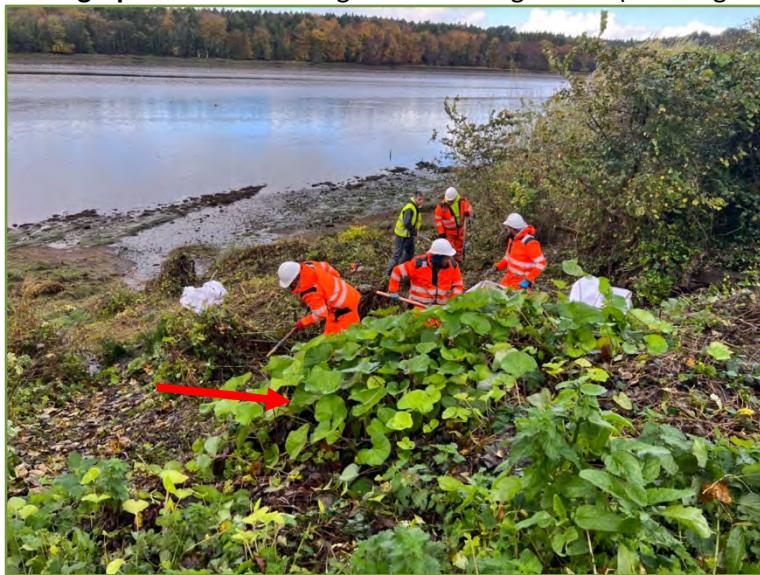
Photograph 2.4. Hand raking of cleared vegetation (avoiding areas of Winter Heliotrope – red arrow)

- All material that was cut on the spring was raked and removed from site (Photograph 2.4). The rakes were used lightly so as not to damage any petrifying springs vegetation below. Some Ivy stem mats were left on the upper bank as clearance could have led to later erosion from bare soil. However, most of the woody/ scrub debris was able to be removed.

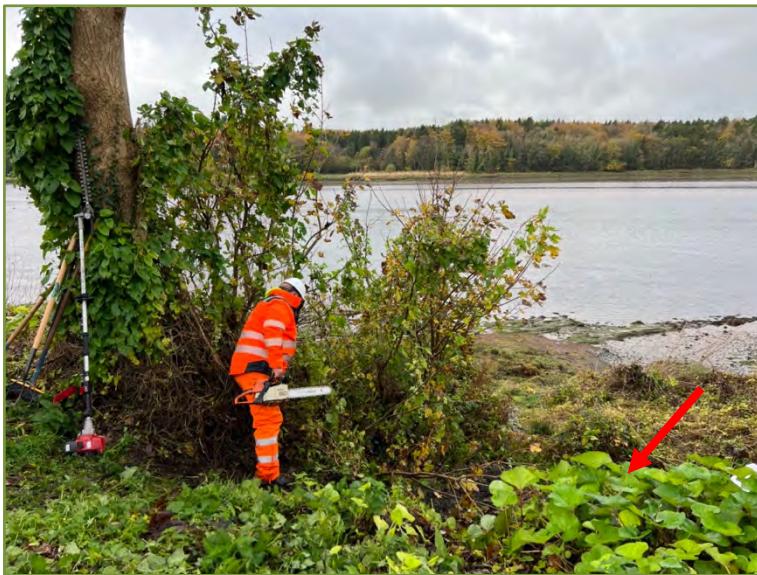
Photograph 2.5. Topping of hedgerow shading spring from south (avoiding area of Winter Heliotrope – red arrow)

- The scrub/ treeline to the south of the spring was topped (not removed) to reduce shading of the spring but avoid disturbance of Winter Heliotrope which was growing nearby (Photograph 2.5).

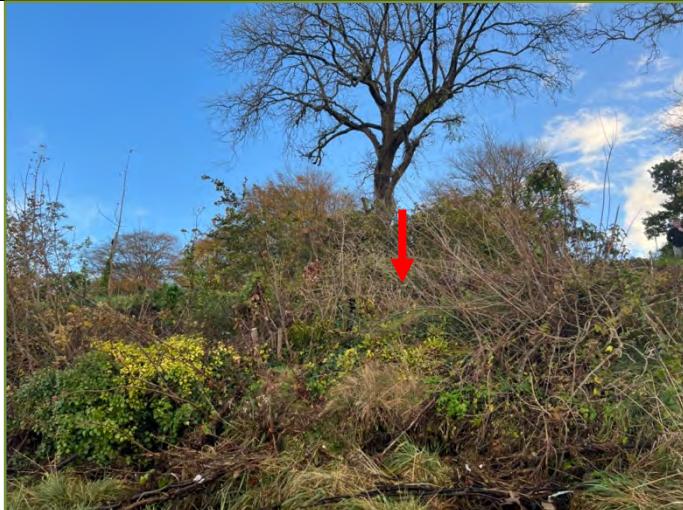
Photograph 2.6a. Before vegetation clearance – mound of petrifying spring hidden beneath scrub (view to E from estuary)

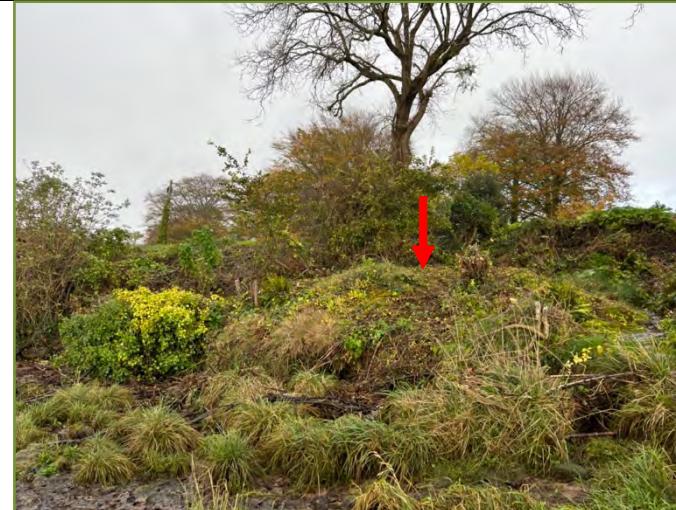
Photograph 2.6b. After vegetation clearance – mound of petrifying spring can now be seen (view to E from estuary)

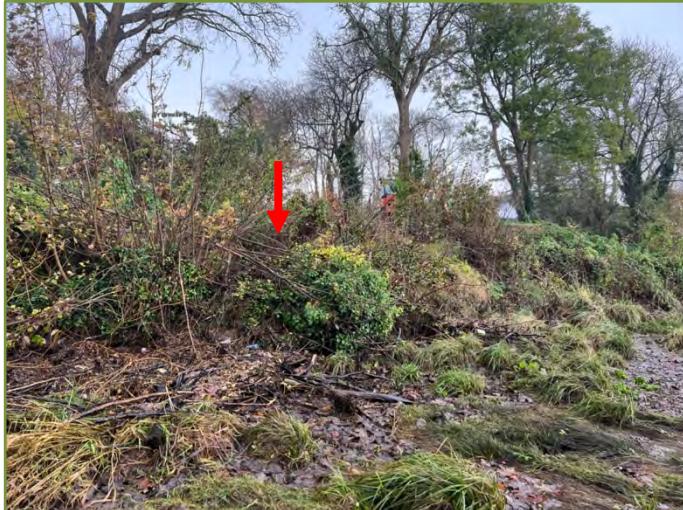
Photograph 2.7a. Before vegetation clearance – most of petrifying spring hidden beneath scrub (view to SE from estuary)

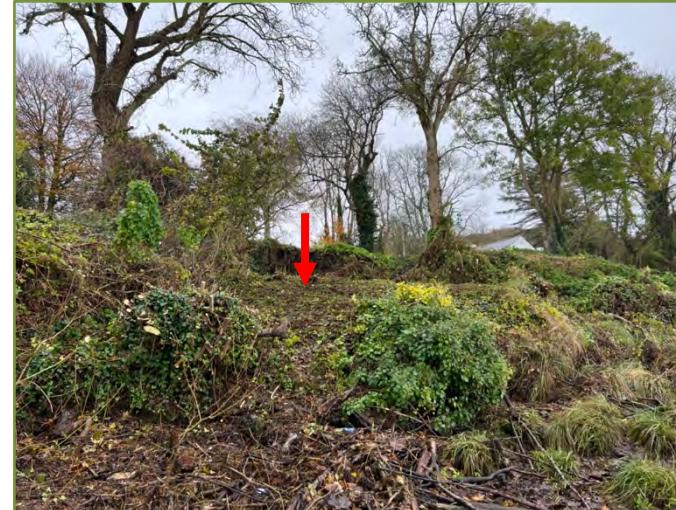
Photograph 2.7b. After vegetation clearance – petrifying spring mound now visible (view to SE from estuary)

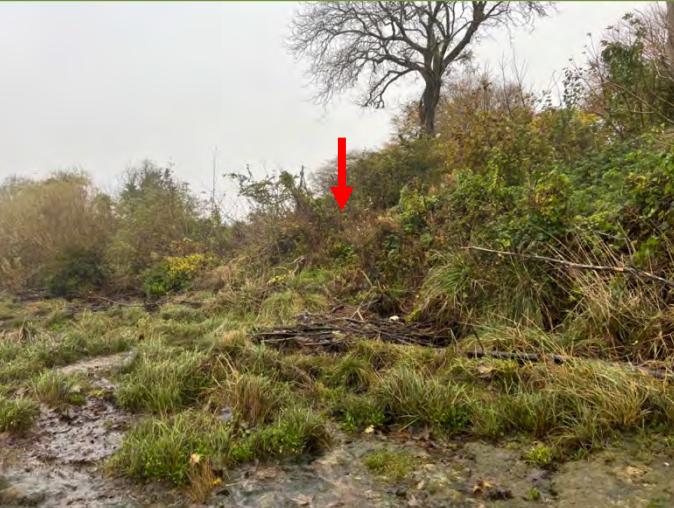
<p>Photograph 2.8a. Before vegetation clearance – petrifying spring hidden beneath scrub (view to NE from estuary)</p>

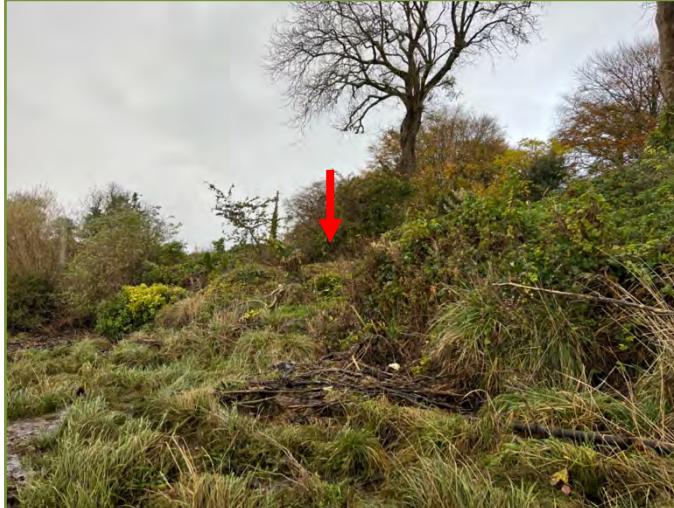
<p>Photograph 2.8b. After vegetation clearance – petrifying spring mound now visible (view to SE from estuary)</p>

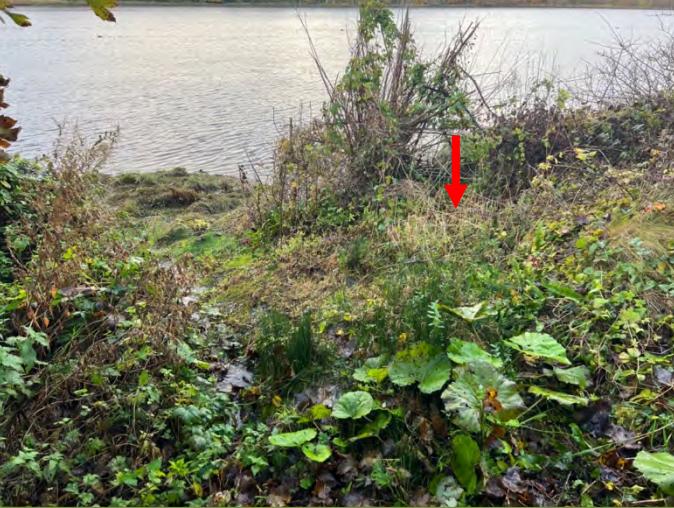
<p>Photograph 2.9a. Before vegetation clearance – most of petrifying spring hidden beneath scrub and second water channel not visible (view to W from roadside)</p>

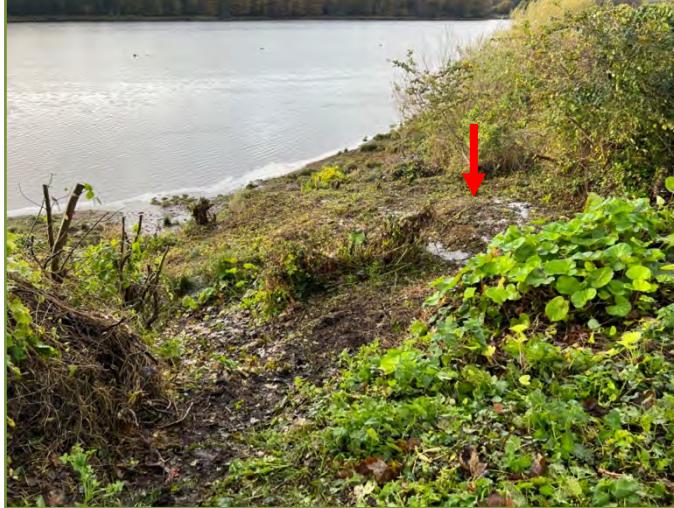
<p>Photograph 2.9b. After vegetation clearance – petrifying spring mound exposed and water flow on N part now visible (view to W from roadside)</p>

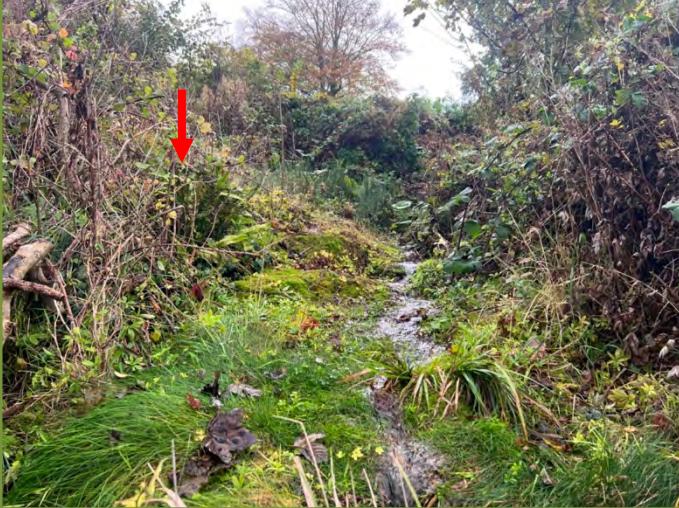
<p>Photograph 2.10a. Before vegetation clearance – only a narrow channel still open, due to scrub on northern section of petrifying spring (view to E from estuary)</p>

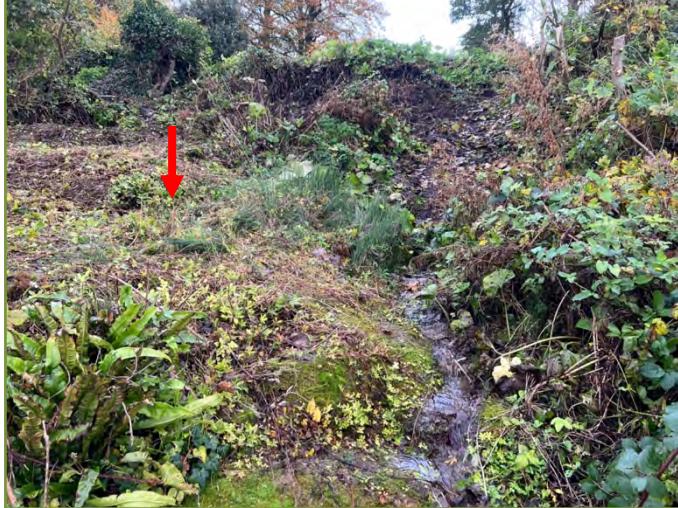
<p>Photograph 2.10b. After vegetation clearance – northern section of petrifying spring mound now exposed (view to E from estuary)</p>

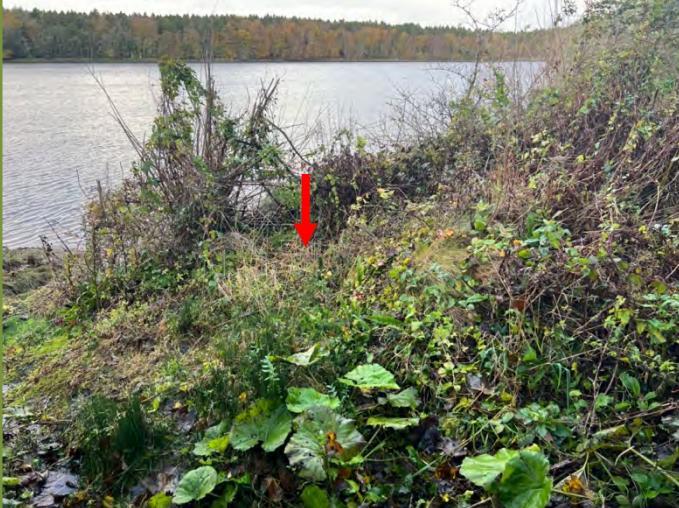
<p>Photograph 2.11a. Before vegetation clearance – the northern part of the mound completely covered in scrub (view to NW from top of bank)</p>

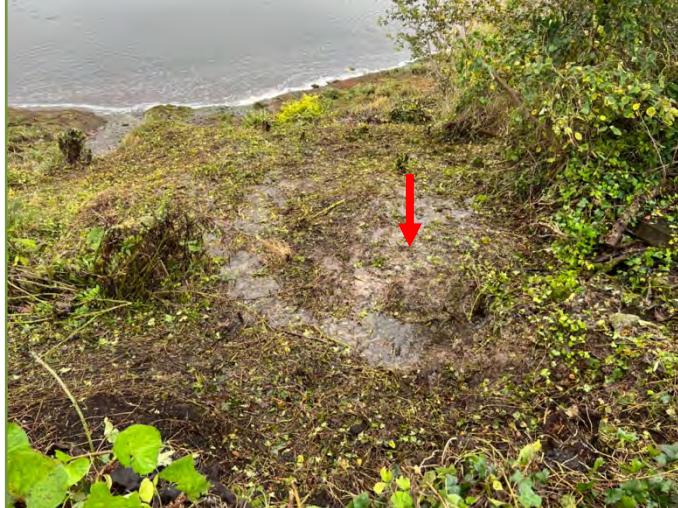
<p>Photograph 2.11b. After vegetation clearance – northern section of petrifying spring mound exposed and water flow visible (view to NW from top of bank)</p>

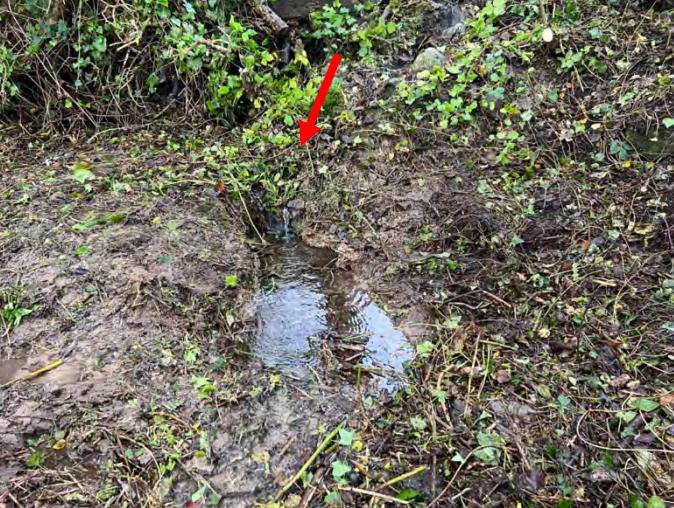
<p>Photograph 2.12. Area where water flows into spring (after flowing under road) now visible (view to N)</p>

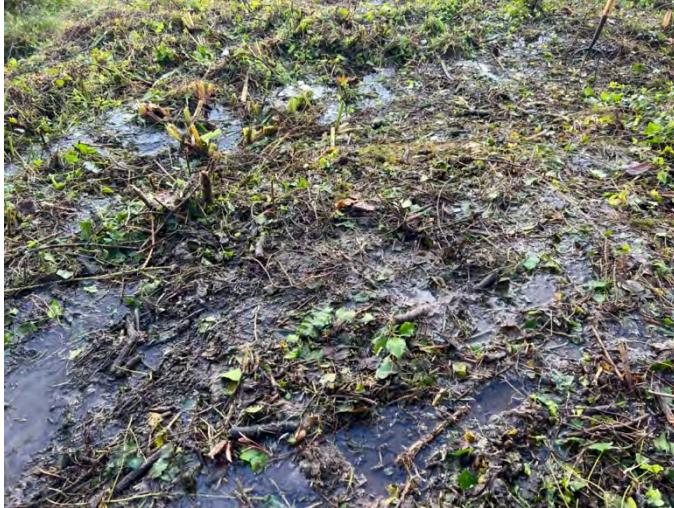
<p>Photograph 2.13. Water visible flowing across area of spring which was previously covered by scrub</p>

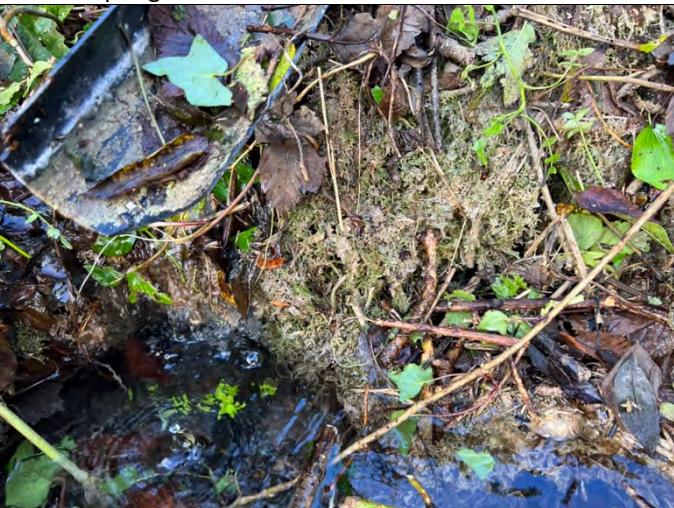
<p>Photograph 2.14. Tufa and petrifying spring bryophytes in area newly cleared of scrub on spring mound</p>

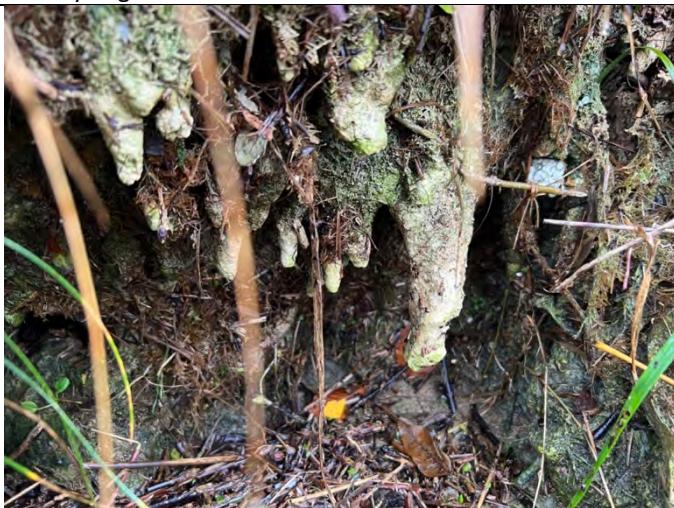
<p>Photograph 2.15. Tufa formation on roots and other woody material at the estuary edge of the mound</p>

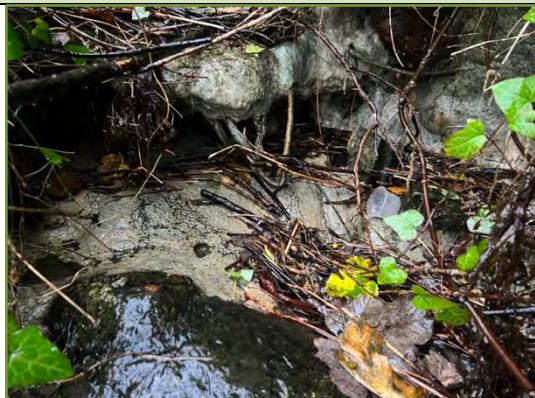
Site	Description	Photo
Site 1 Seasonal springs along the shoreline from the Old Quay House main spring (Figures 1.1 & 4.1)	Northern point on Figure 4.1. Tufa present on rocks with some flow. No bryophytes or flowering plants that are indicative of petrifying springs present. Unclear if slight flow was due to recent heavy rain or if there is permanent seepage here. = Non-Annex tufa forming spring

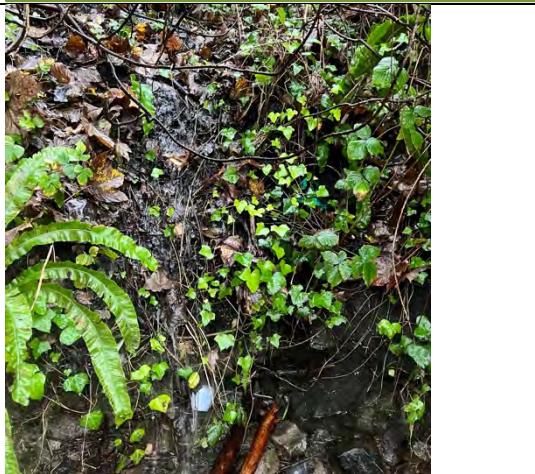
Seasonal stream flowing from estuary bank. No bryophytes or flowering plants that are indicative of petrifying springs present and no tufa observed. =Non-Annex spring/ stream

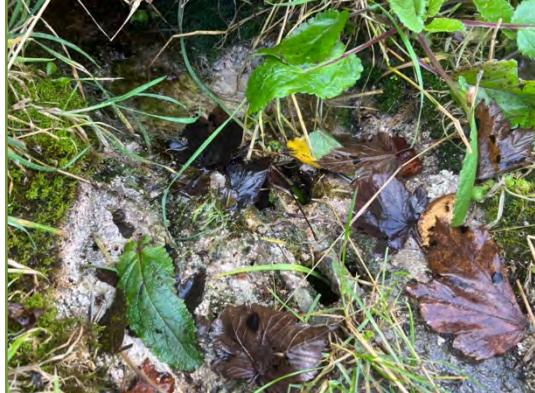
Site	Description	Photo
Site 2 Roadside tufa, nr Killanley Church (Figure 1.1)	This site is located within and adjacent to an inland area of the Moy Estuary SAC (Figure 1.1.). Tufa forms around drains at the edge of a field and it is possible that there is tufa formation within the field. The bryophytes <i>Pellia endiviifolia</i> and <i>Cratoneuron filicinum</i> were present. Although heavily tufa forming, there were not enough positive indicator species present for this to be an example of an Annex I petrifying springs. However, there may be additional tufa springs in this area in areas that are less disturbed by drain cleaning and which have more species. = Non-Annex tufa forming spring

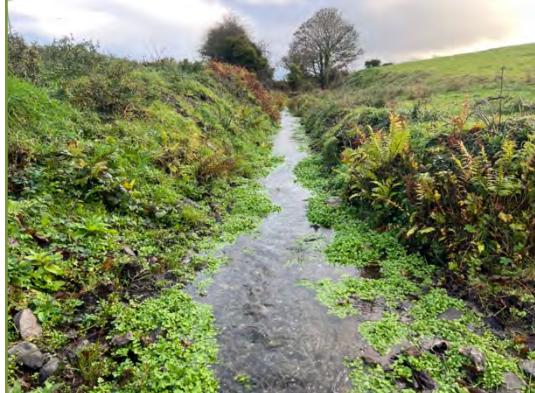
Site 3 Stream with potential tufa, nr Killanley Church (Figure 1.1)	This is a small stream which flows through farmland. The pH of the stream was 7.5 so it is a calcareous stream and possibly partially spring fed. Watercress <i>Nasturtium officinale</i> was dominant in the channel. However, no tufa was observed. A water sample showed that nitrate (0.66 mg/l) and ortho-phosphate (12.0 µg/l) were under the threshold level for good condition in a petrifying spring (although the phosphates are still moderately high). = Non-Annex spring fed stream (no tufa)

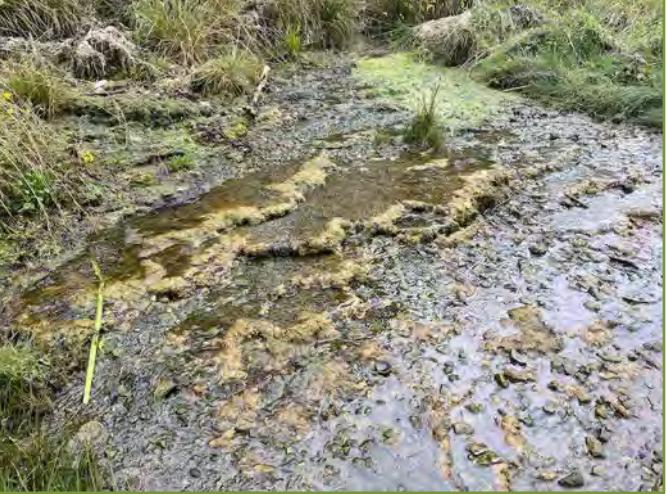
<p>Photograph 1.2. Tufa cascades where spring joins estuary (view to south)</p>

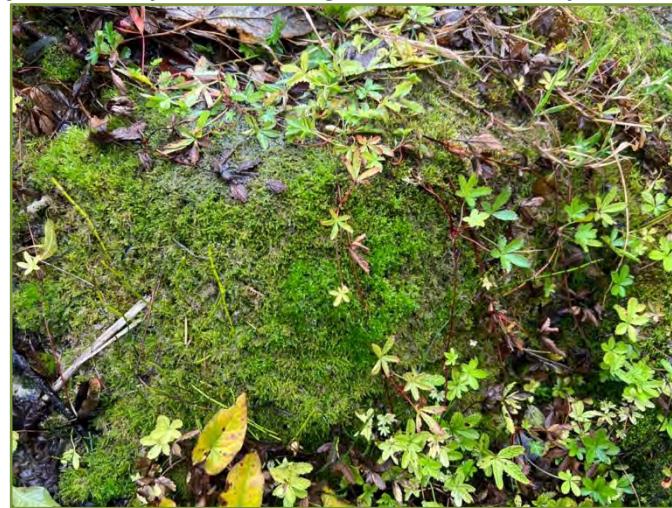
- In 2022 the monitoring plot failed 2 criteria: invasive species and negative bryophyte indicator species (as one species *Cratoneuron filicinum*, was abundant).

Photograph 2.2. Relevé (view to W)	Photograph 2.3. Vegetation within relevé (<i>Cratoneuron filicinum</i>, <i>Equisetum variegatum</i>, <i>Potentilla reptans</i>)
