**OLD QUAY SCHOOL BALLINA
PETRIFYING SPRING SOIL REMOVAL AND SCRUB CLEARANCE
February 2024**

March 2024

Report produced by Denyer Ecology

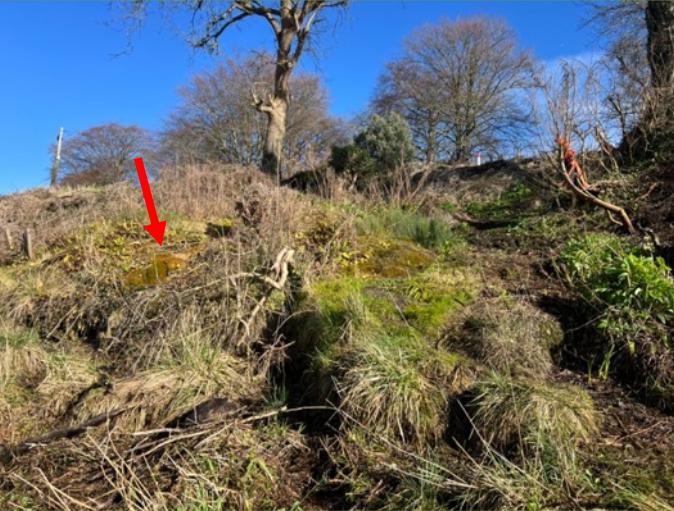
Photos of the spring mound before and after vegetation clearance are shown in Photographs 2.1-2.2. There had been some re-growth of woody and tall vegetation since the previous clearance in autumn 2022, although this is difficult to see in the photographs as it was winter (and vegetation had died back). Clearance of the vegetation allows more light onto the petrifying spring vegetation (e.g. Photograph 2.2b), reduces the drying effect of woody vegetation and reduces nutrient levels within the spring.

<p>Photograph 2.1a. Before vegetation clearance with woody vegetation regrowth in the area formerly covered in scrub (view to E from estuary)</p>

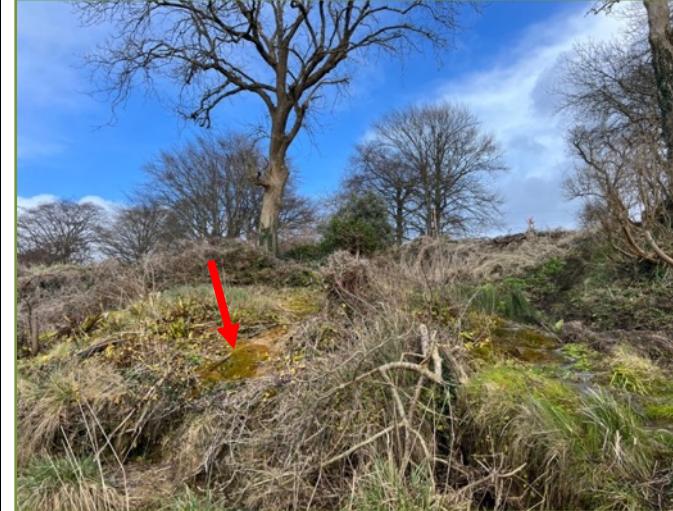
<p>Photograph 2.1b. After vegetation clearance with scrub removed and bryophytes more visible (view to E from estuary)</p>

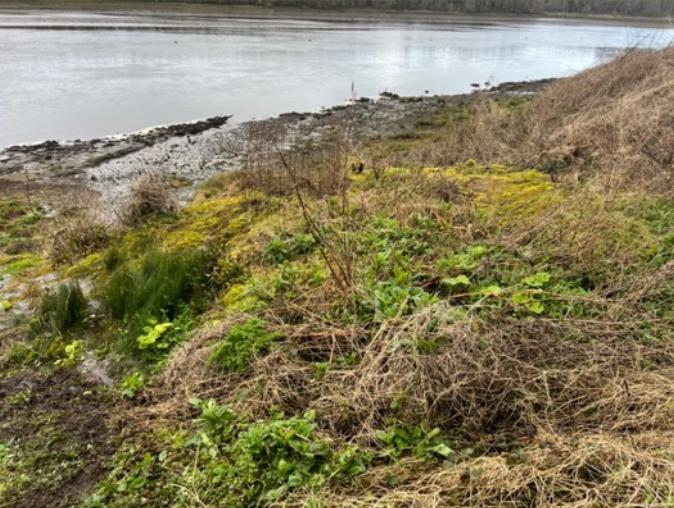
<p>Photograph 2.2a. Before vegetation clearance with woody vegetation (view to NW from roadside)</p>

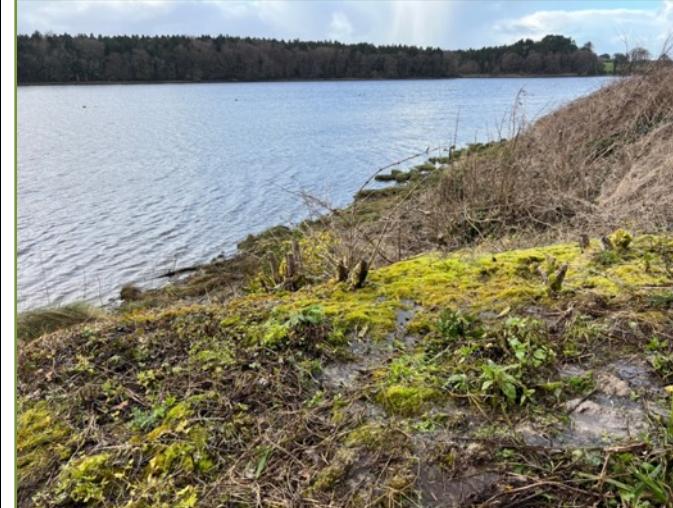
<p>Photograph 2.2b. After vegetation clearance with bryophytes and spring flow more visible (view to NW from roadside)</p>

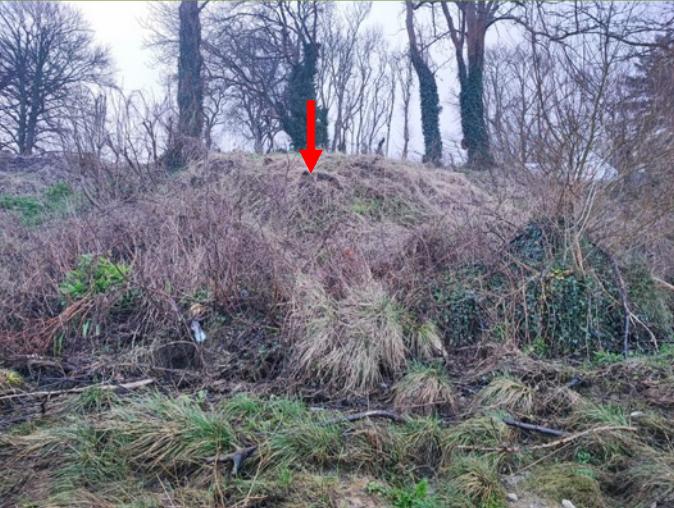
<p>Photograph 2.3a. Before soil removal – the area is covered with dumped garden waste (view to E from estuary)</p>

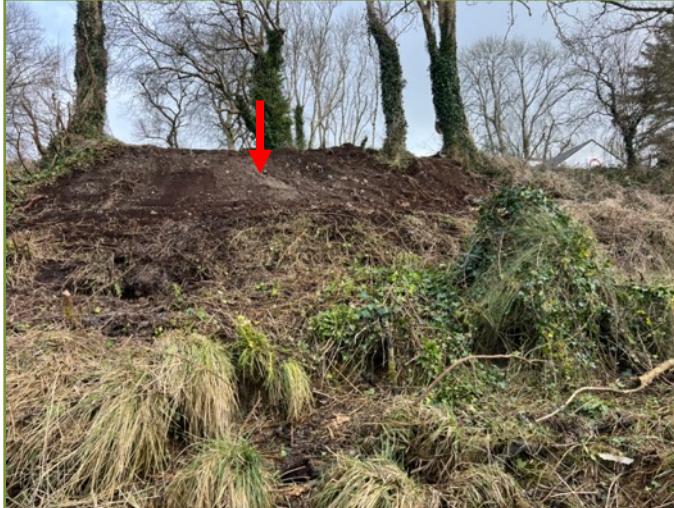
<p>Photograph 2.3b. After soil removal – the natural profile of the bank is now visible (view to E from estuary)</p>

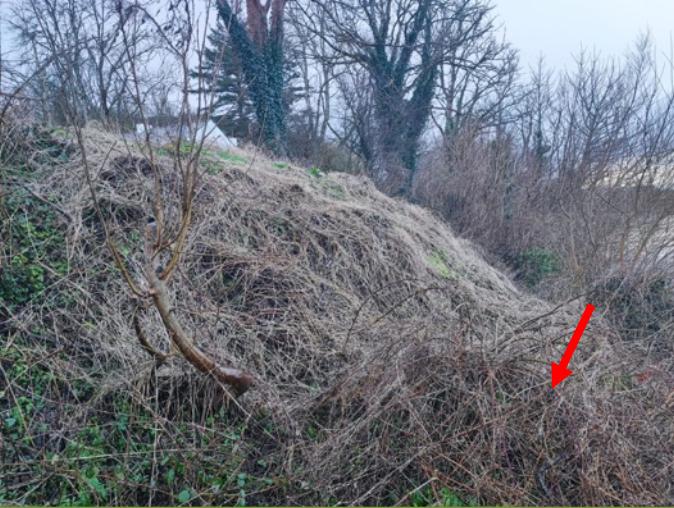
<p>Photograph 2.4a. Before soil removal – the area is covered with dumped garden waste and the spring is covered with woody vegetation (view to E from estuary)</p>

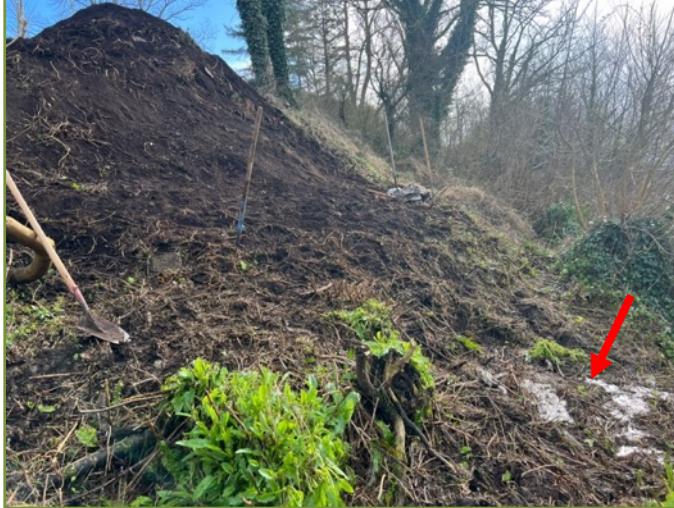
A spring was uncovered on the lower part of the bank (Photograph 2.4b). This had good water flow and some tufa formation near the spring source (Photographs 2.5a-2.5b). In addition, there was some paludal tufa formation on bryophytes (Photograph 2.6) and strong cascade tufa formation on the bank where the spring joins the estuary (Photograph 2.7). There were at least two further springs emerging on the bank to the south (Photographs 2.8-2.9), but it wasn't possible to reach these areas with the mechanical digger. Scrub was cleared by hand as much as possible to increase light in these areas.

<p>Photograph 2.4b. After soil removal – spring exposed from under scrub (view to E from estuary) [the soil pile on top of the bank was later removed].</p>

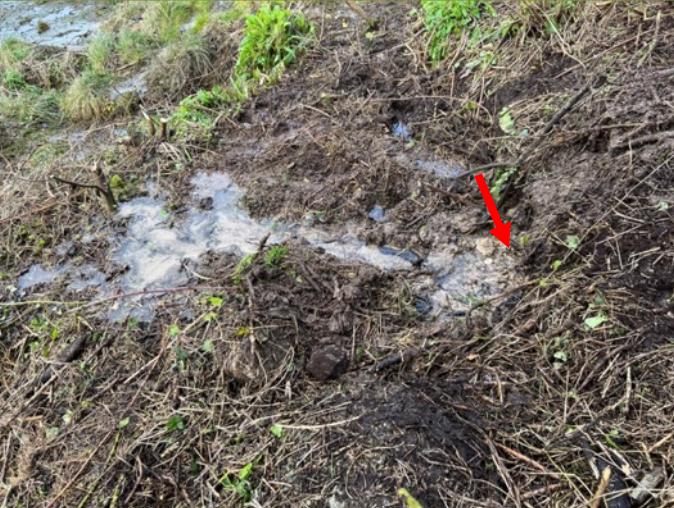
<p>Photograph 2.5a. Newly exposed spring with water emergence point shown by red arrow. Tufa formation (pale/ white colour) is visible (view to N)</p>

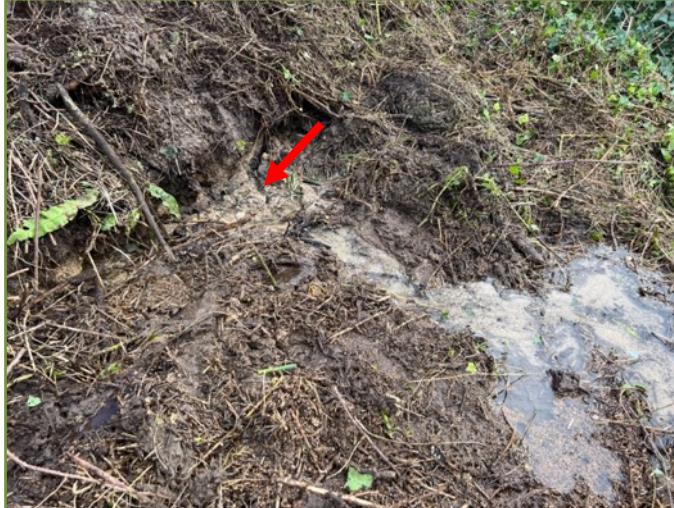
<p>Photograph 2.5b. Newly exposed spring with water emergence point shown by red arrow. Tufa formation (pale/ white colour) is visible (view to S)</p>

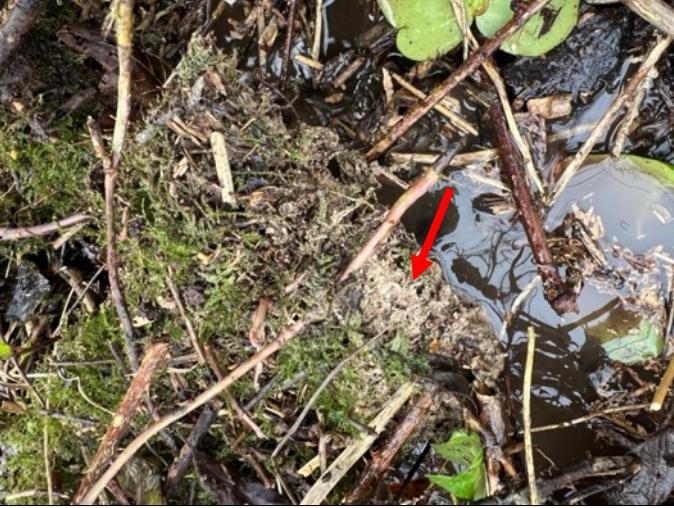
<p>Photograph 2.6. Paludal tufa (white crust) formation on bryophytes in newly exposed spring</p>

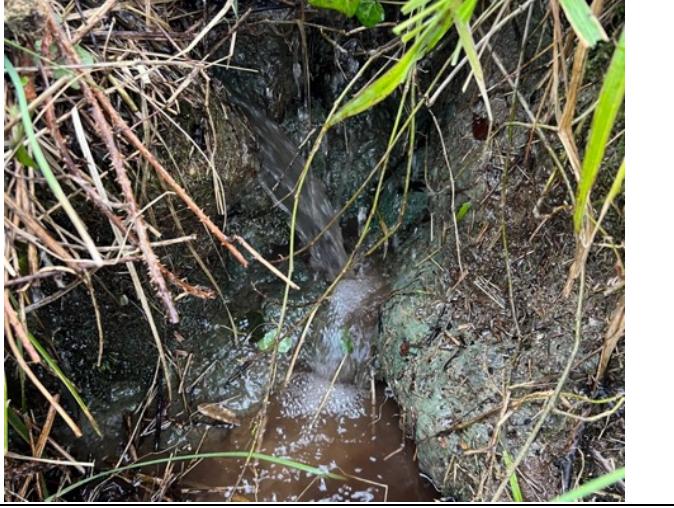
<p>Photograph 2.7. Strong tufa formation, with blue colour from cyanobacteria/ algae on the tufa, where newly exposed spring flows over bank into estuary</p>

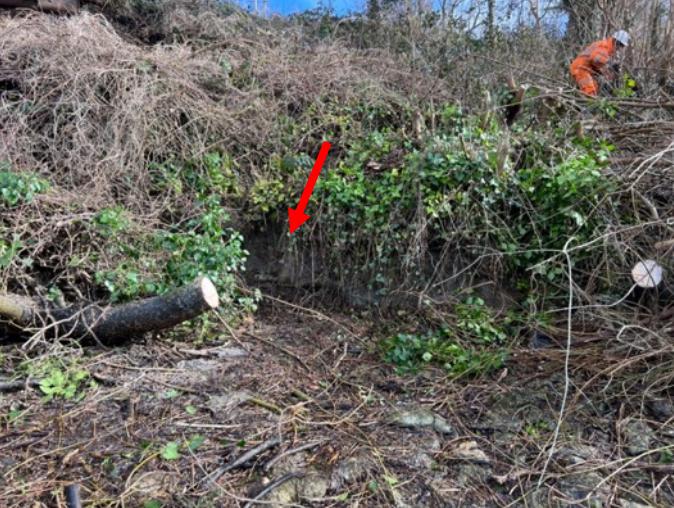
<p>Photograph 2.8. Spring to the south of the newly exposed spring, with hand clearance of scrub (view to E from estuary)</p>

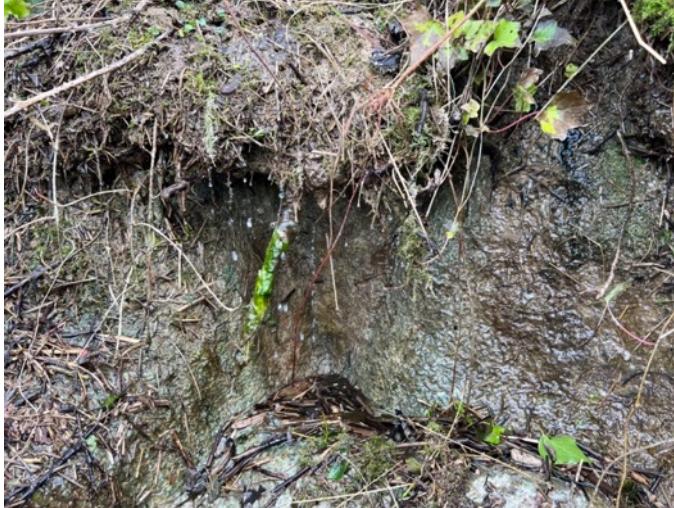
<p>Photograph 2.9. Tufa formation on estuary bank from additional spring to south</p>
