**PETRIFYING SPRING SURVEY AND ASSESSMENT
MOY ESTUARY, CO. MAYO**

December 2021

- Denyer Ecology was commissioned by River Moy Search and Rescue Ballina to undertake petrifying springs **surveys** and **Conservation Status Assessment** of a section of the River Moy Estuary.

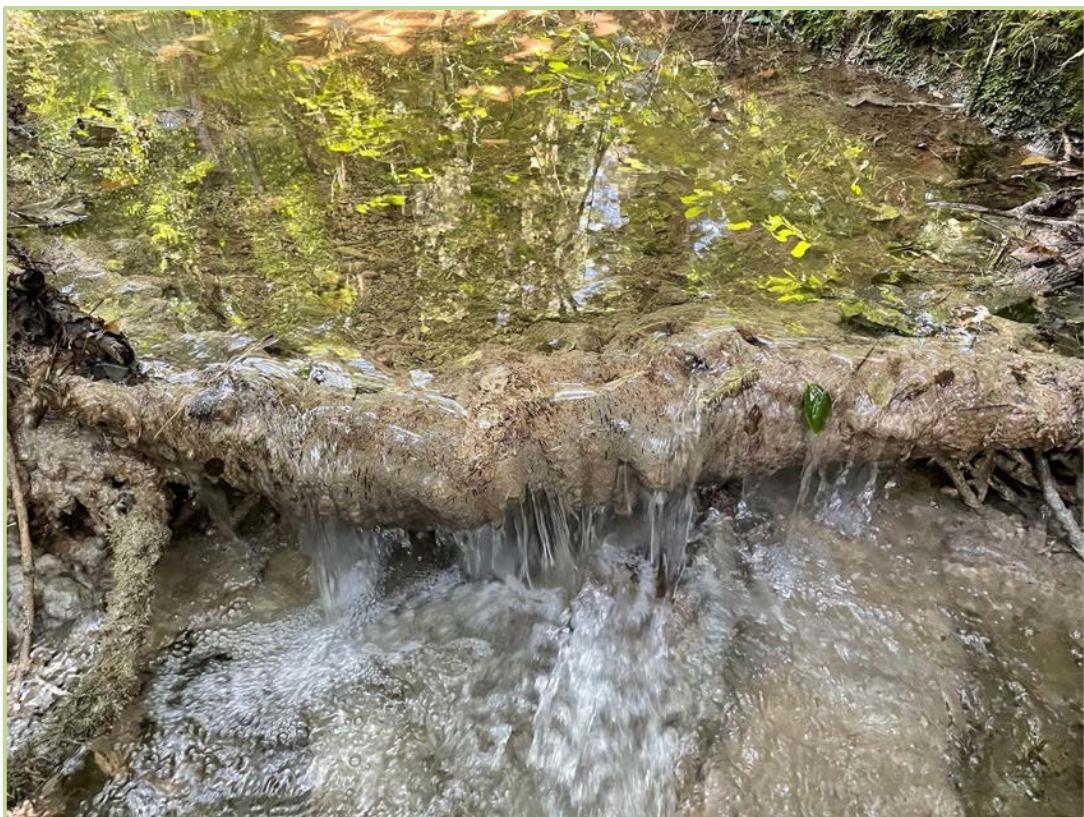
Tufa dam in stream in Belleek Woods (North), Co. Mayo (photograph by Joanne Denyer)

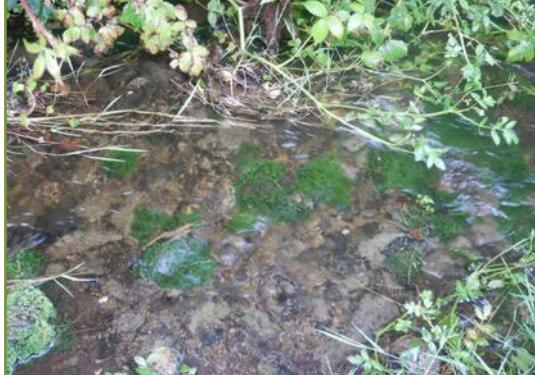
Spring ID	Comment	Photograph
M05	This roadside stream has high cover of <i>Pellia endiviifolia</i> and good tufa cover. Only 1 positive indicator is present. However, downstream (M07) supports *7220 vegetation and so M05 is considered to be part of this *7220 system.

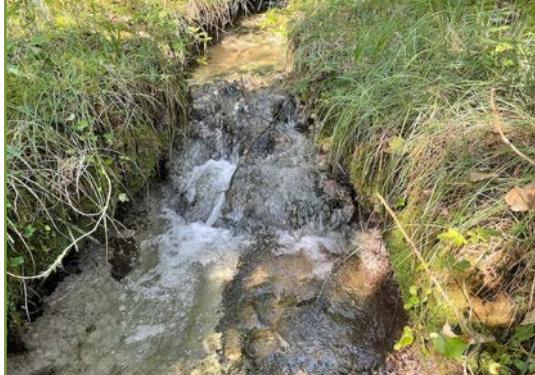
M06	This is the main stream flowing through Belleek Woods (north). Tufa is in the form of extensive areas of stream crust, cascade tufa and occasional oncoids/ ooids. *7220 positive indicator species are locally frequent. There are many tributaries which feed into this main stream and most also have extensive tufa formation.

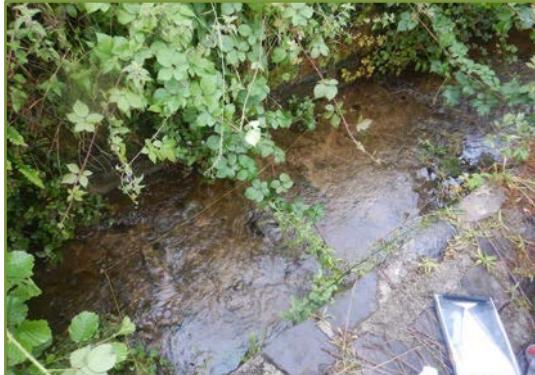
M07	Section of roadside stream along Clegg's Lane, downstream from M05. This section is located just to the east of the coast/ Quay road. Despite the channel having been modified, tufa cascades and *7220 positive indicator species are frequent in this section of the stream.

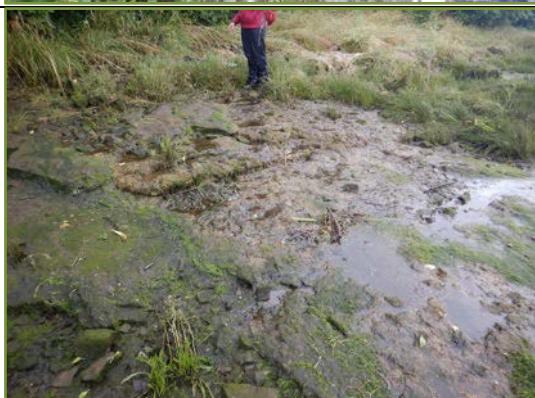
M08	This spring seeps from the roadside bank into the estuary. It extends ca. 10m along the shore. There are small tufa cascades at the estuary edge which are algal covered. No *7220 positive indicator species were present.

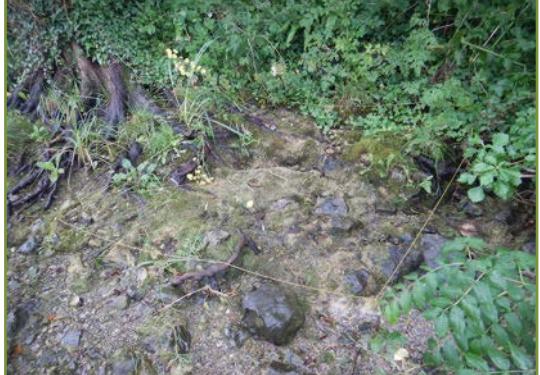
Spring ID	Comment	Photograph
M09	Seepage area arising from the eastern estuary bank. There was a small water flow at the time of survey but the whole spring area was damp. There is cascade tufa formed at the base of the bank with species-rich bryophyte vegetation and some vascular plants. This plot had the highest number (9) of positive indicator species within the Moy Estuary survey area, of which 8 were bryophytes. The spring flows into the estuary and there is filamentous algae in the brackish zone below the relevé plot location.

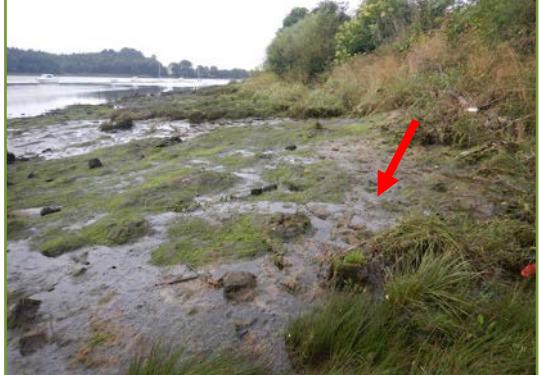
M10	This is part of the seepage spring area along the estuary from the Quay House to Pump House. Tufa cascades with algae are present at the estuary edge. However, as with M08 there were no *7220 positive indicator species recorded.

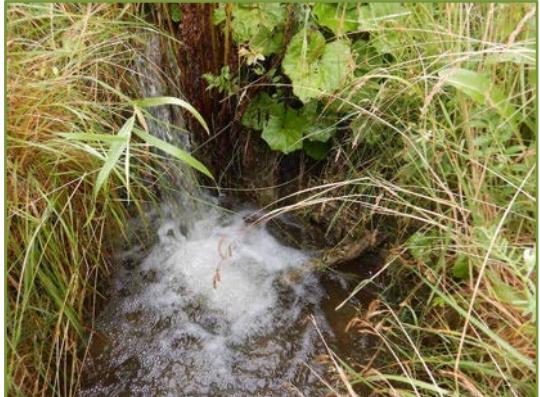
M11	This is a small spring which discharges from the estuary bank. It had a fast flow. Tufa (cascade, paludal and oncoids and ooids) was restricted to the area around the outflow from the bank. The area was too small for a plot but had three positive indicator species present (<i>Eucladium verticillatum</i> , <i>Didymodon tophaceus</i> and <i>Pellia endiviifolia</i>) and is *7220 habitat.

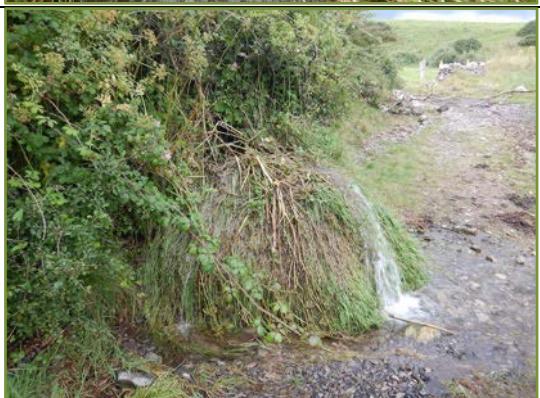
M12	This is a spring which discharges from the northern bank of a small inlet. Where the spring arises from the bank, it has formed a large tufa mound over 1m in height and several metres in diameter. This is covered in grass (<i>Agrostis stolonifera</i>) which has reduced species diversity. Where grass cover is lower (eastern side of mound), *7220 bryophyte species are locally frequent.

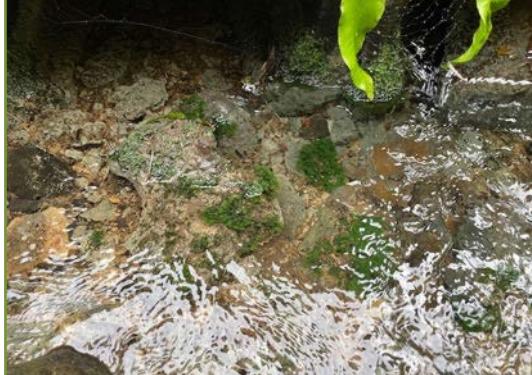
Spring ID	Comment	Photograph
M17	This is a small roadside stream with frequent tufa formation. The only *7220 species present is <i>Pellia endiviifolia</i> . Cyanobacteria sp. (bluish colour) is locally frequent.

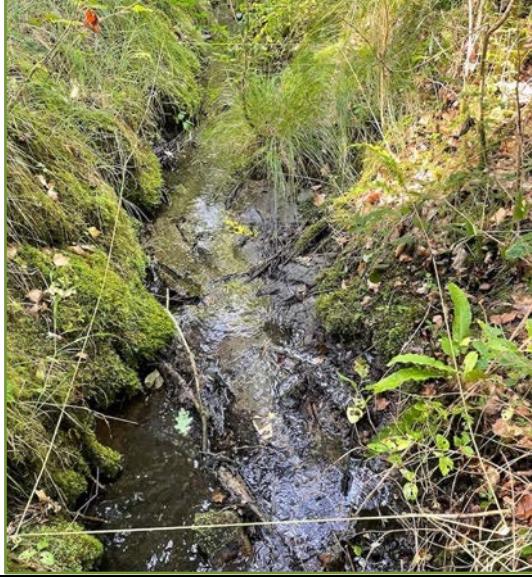
M18	This is a tributary to M06 in Belleek Woods (north). This stream section in spring M18 had lower tufa than the downstream section, but higher cover of petrifying spring species. In-stream bryophytes include abundant <i>Palustriella commutata</i> and <i>Pellia endiviifolia</i> and frequent <i>Fissidens adianthoides</i> (all *7220 positive indicator species).

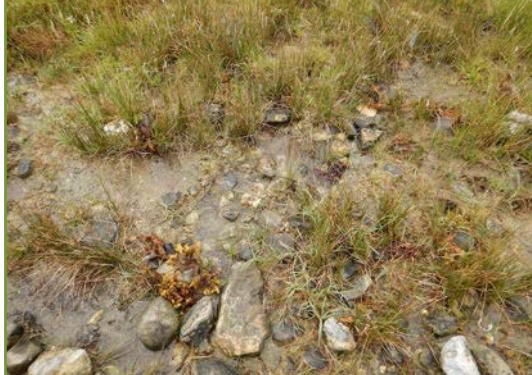
M19	This is a seepage spring from the eastern estuary bank. Tufa is present but there are no *7220 positive indicator species.

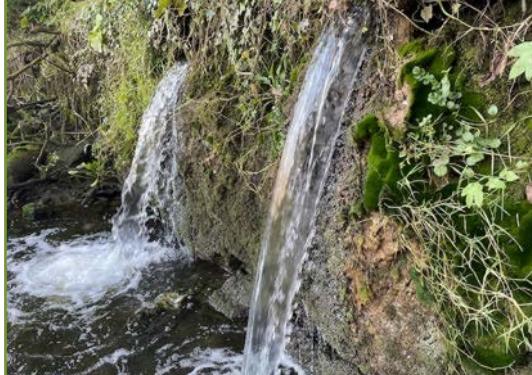
M20	This is the outflow to the pond in Belleek Woods (south). There is a large tufa cascade beneath the outflows. Some *7220 species are present but the outflow was not accessible for detailed survey. There is a high cover of algae and it is likely that nutrient levels are high (as there is significant algae cover in the pond feeding the outflows).

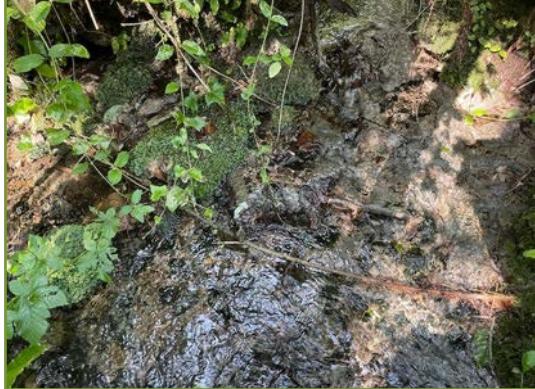
Spring ID	Comment	Photograph
M21	This is part of the Belleek Woods (north) spring system. It was dry at time of survey, but tufa was present in the channel and it is linked to *7220 habitat downstream.	n/a
M22	This is part of the Belleek Woods (north) spring system. It had water flow and there were extensive cascade and stream crust tufa throughout most of the stream. *7220 positive indicator species are locally frequent.

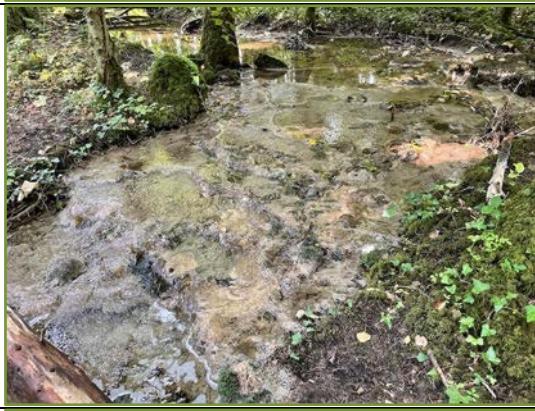
M23	This is part of the Belleek Woods (north) spring system. The stream channel is up to 3m wide in places. Cascade and stream crust tufa are very extensive in some areas and *7220 positive indicator species frequent.

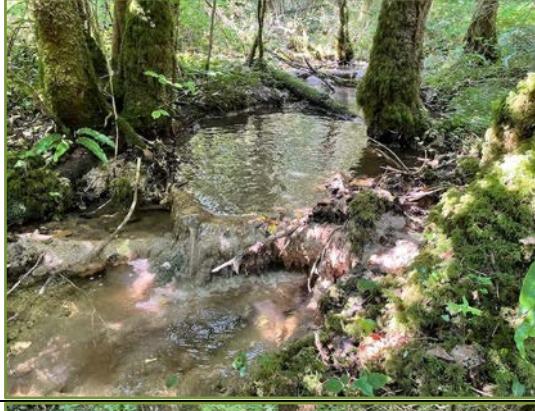
M24	This is part of the Belleek Woods (north) spring system. Extensive cascade and stream crust tufa are present. The streams are adjacent for a section and then join to the west. *7220 positive indicator species frequent.

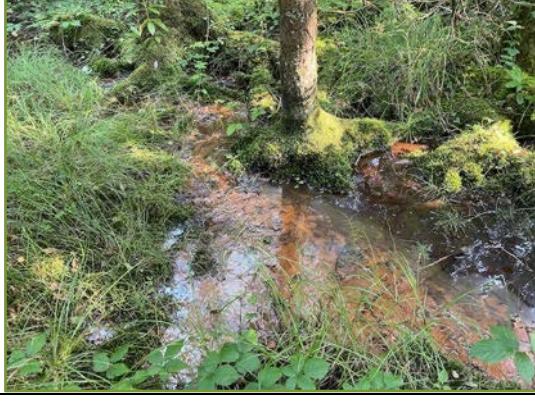
M25	This is part of the Belleek Woods (north) spring system. The small stream runs through wet woodland with iron staining springs frequent in adjacent areas. *7220 positive indicator species are frequent with <i>Fissidens adianthoides</i> is locally abundant.

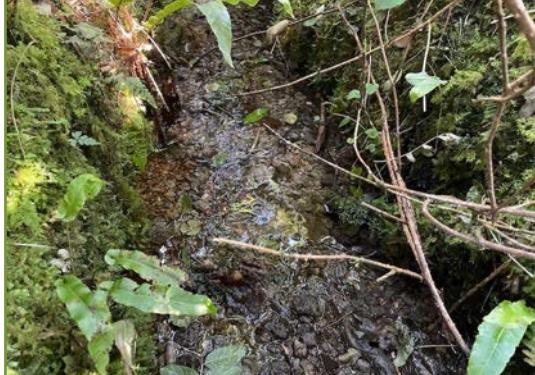
Spring ID	Comment	Photograph
M26	This is part of the Belleek Woods (north) spring system. The stream was dry to east, but wet where it joins the main channel to the west. Tufa was mainly oncoids and ooids.

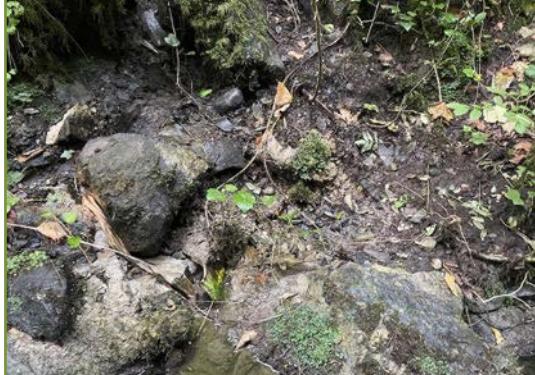
M27	Unlike the stream/ spring system in Belleek Woods (north), this appears to be the only petrifying stream in Belleek Woods south. The tufa in the stream is largely confined to a series of dams, which potentially are artificial in origin but now have cascade tufa on them. The stream flows into a pond (man-made) and then discharges to the estuary from two discharge points with cascade tufa formation. The stream is larger than the streams in Belleek Woods (north) and has less bryophyte cover in the main channel. There are seepages from the riverbanks in the western (upstream) section of the stream.

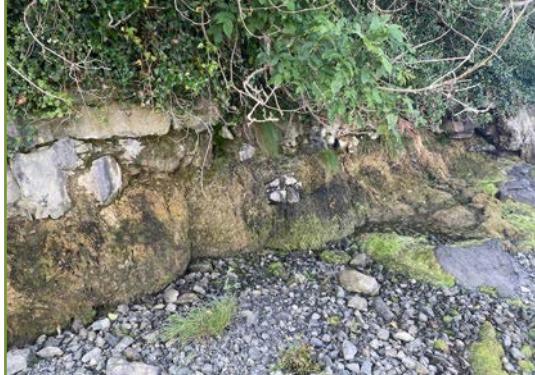
M29	This is a section of the western estuary shoreline with spring seepage and tufa formation. At the time of survey there was no flow, but the tufa areas were damp. There are two main areas of tufa formation: M29 (ca. 20m of shoreline and 2m in height) and M30 (ca. 20m of shoreline and 2m in height). The tufa is both active and inactive and it is likely that the seepage areas have changed slightly over time. The tufa is cascade formation on mainly vertical slopes on the rocky shoreline. Bryophytes dominate the tufa.

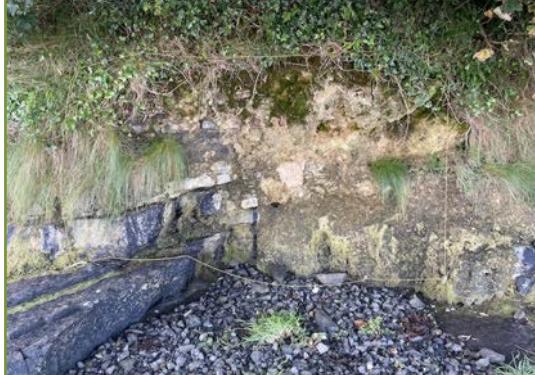
M30	This is a section of the western estuary shoreline with spring seepage and tufa formation. At the time of survey there was no flow, but the tufa areas were damp. There are two main areas of tufa formation: M29 (ca. 20m of shoreline and 2m in height) and M30 (ca. 20m of shoreline and 2m in height). The tufa is both active and inactive and it is likely that the seepage areas have changed slightly over time. The tufa is cascade formation on mainly vertical slopes on the rocky shoreline. Bryophytes dominate the tufa.

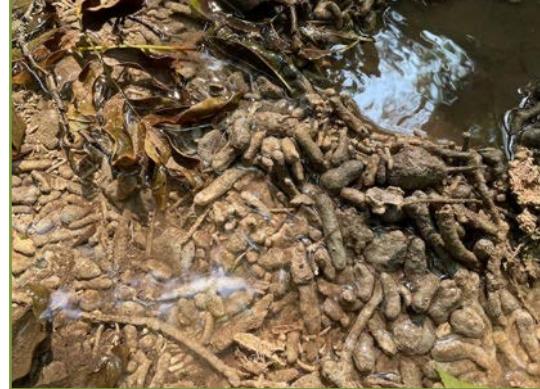
Spring ID	Comment	Photograph
M31	This is part of the Belleek Woods (north) spring system. The stream was dry to the east, but there was flow where it joins the main stream (M06). Tufa is occasional.	n/a
M32	This is part of the Belleek Woods (north) spring system. This is a small section of stream which joins stream M22 just upstream of where M22 joins M06. Oncoids and ooids (tufa formation around stones and debris – shown in photo to right) were abundant in the channel.

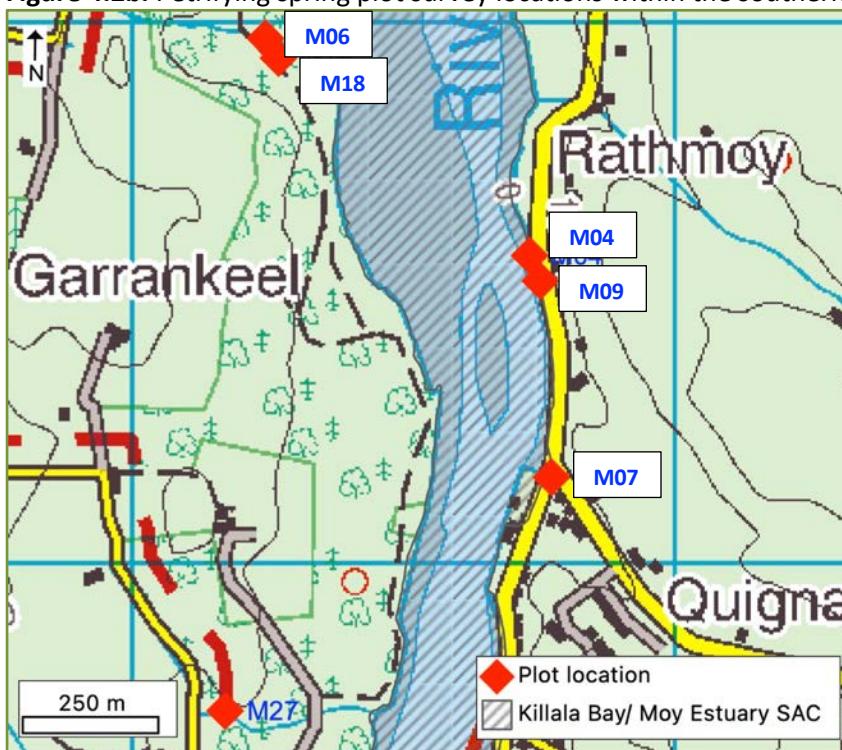
Figure 4.2b. Petrifying spring plot survey locations within the southern survey area

Ten plots were undertaken (MR01-MR10, Figure 4.2a-b). A summary of the results is shown in Tables 4.4 and 4.5, and the full results of the plot survey and condition assessment are shown in Appendix B.

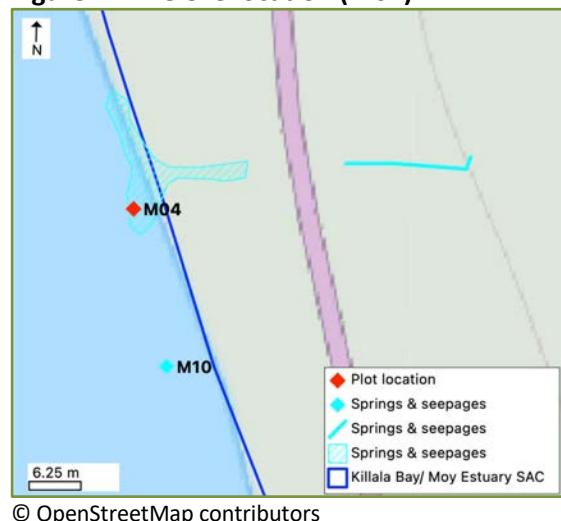
Figure 2.1. Relevé location (M04)

Spring description: This is a spring which arises in a property to the east of the coast road. It flows down the hill and under the road. Below the road it forms a large tufa mound (Figure 2.1) and discharges into the estuary. The main tufa formation is cascade tufa but there is also significant stream crust tufa in the main spring channel and some paludal tufa. The tufa mound extends approximately 20m along the shoreline. Where the spring joins the estuary, the tufa cascades are algal covered. Much of the main tufa mound is dominated by trees and scrub. The relevé was undertaken in the area with the highest cover of petrifying spring vegetation. The vegetation is bryophyte dominated, with abundant *Palustriella commutata* and occasional to frequent *Bryum pseudotriquetrum*, *Palustriella falcata* and *Brachythecium rivulare*. The main vascular plants are *Agrostis stolonifera*, *Festuca rubra* and *Potentilla reptans* with patches of *Equisetum variegatum*.

The relevé (Figure 2.1; red arrow Photograph 2.1) is located on the top of the tufa mound.

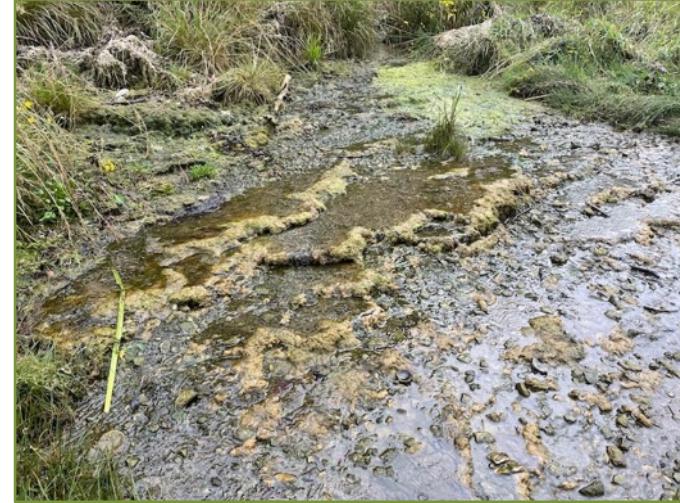
Photograph 2.2. Tufa cascades where spring joins estuary (view to south)

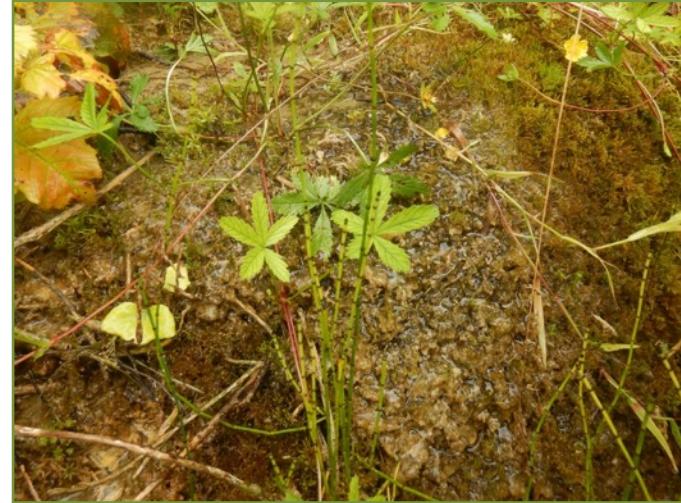
Photograph 2.3. Vegetation within relevé (*Palustriella commutata*, *Equisetum variegatum*, *Potentilla reptans*)

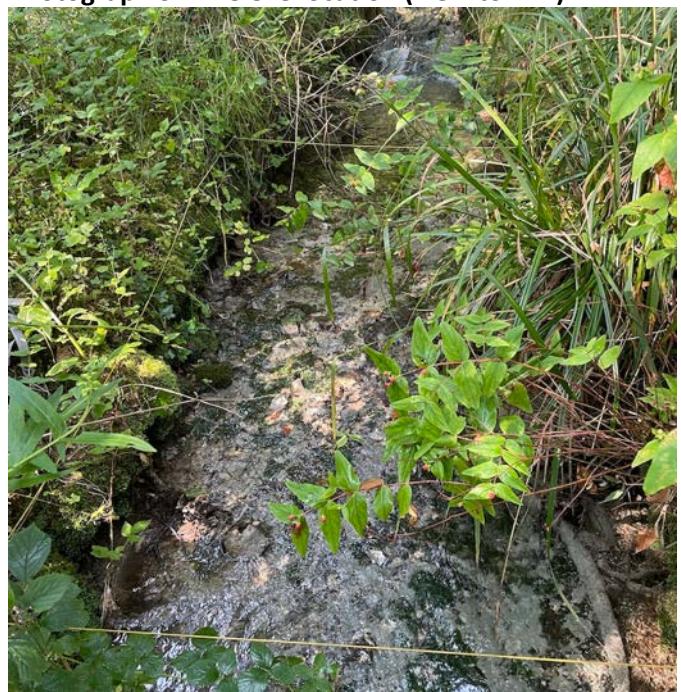
Photograph 3.1. Relevé location (view to NW)

The relevé (Figure 3.1; Photograph 3.1) is located in the lower section of spring M06. This spring originates in the north of the site (between M25 and M26 in Figure 3.1)

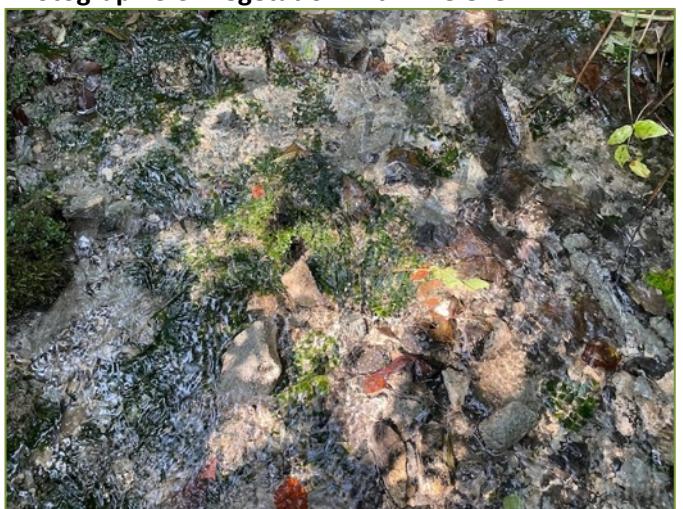
Photograph 3.2. View upstream (west) from relevé	Photograph 3.3. Vegetation within relevé

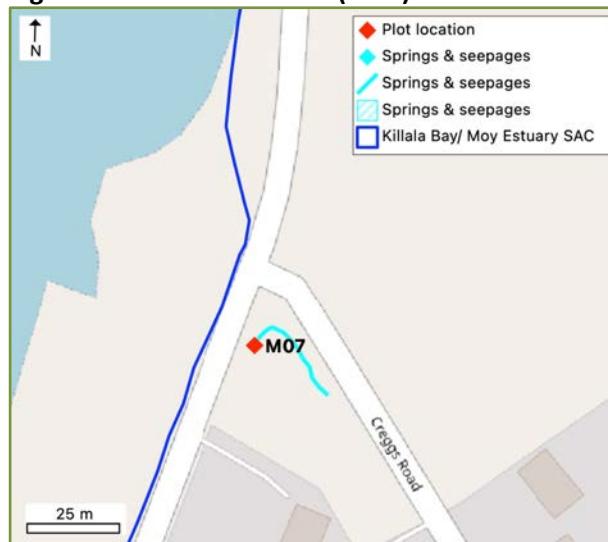
Figure 4.1. Relevé location (M07)

The relevé (Figure 4.1; Photograph 4.1) is located at the junction of Cregg's Road and the Quay Road

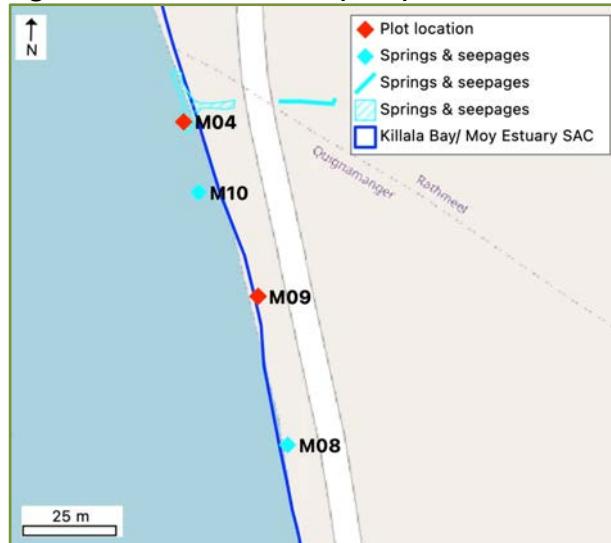
The vegetation has most affinity with Group 2 <i>Palustriella commutata</i>-<i>Geranium robertianum</i> Springheads vegetation community (Lyons & Kelly, 2017).		
Relevé location: The relevé (Figure 5.1; Photograph 5.1) is located ca. 30m west (downstream) of the coast road		
Figure 5.1. Relevé location (M09)

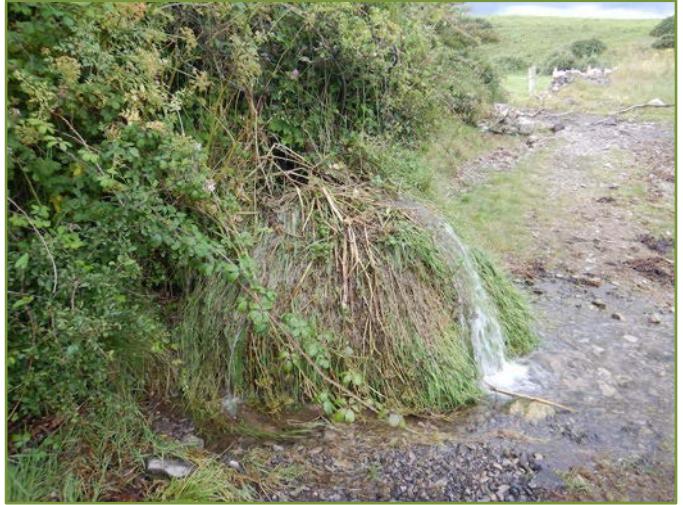
Photograph 6.1. Relevé (whole mound) (view to E)

The vegetation has most affinity to Group 4 Palustriella commutata-Agrostis stolonifera Springheads vegetation community (Lyons & Kelly, 2017).		
Relevé location: The relevé (Figure 6.1; Photograph 6.1) is located in a small inlet near Knockroe, N Castleconner.		
Figure 6.1. Relevé location (M12)

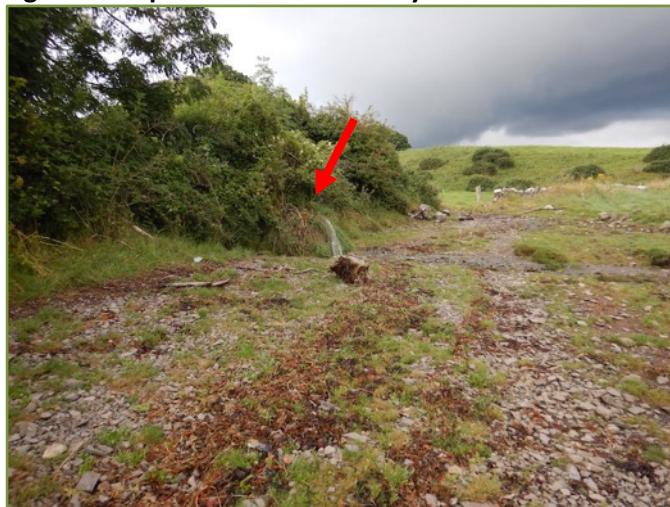
Photograph 6.2. View of tufa mound (red arrow) within estuary (view to southeast). Water discharges to the right of the photo into the estuary.

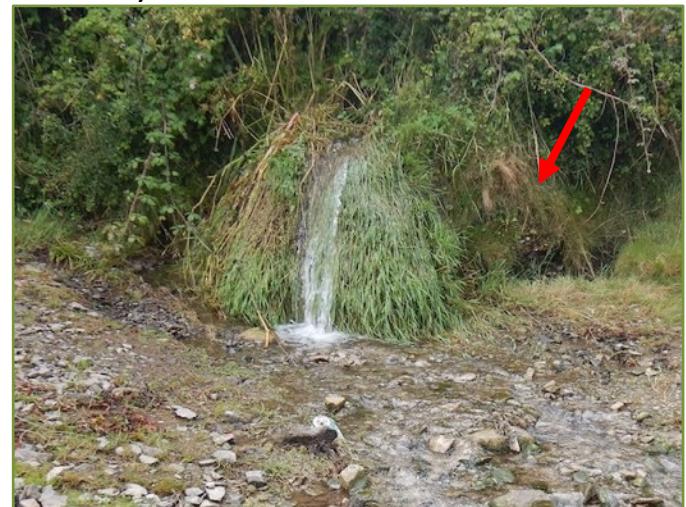
Photograph 6.3. Vegetation within relevé. Area with *Didymodon tophaceus* shown by red arrow (view to north east).

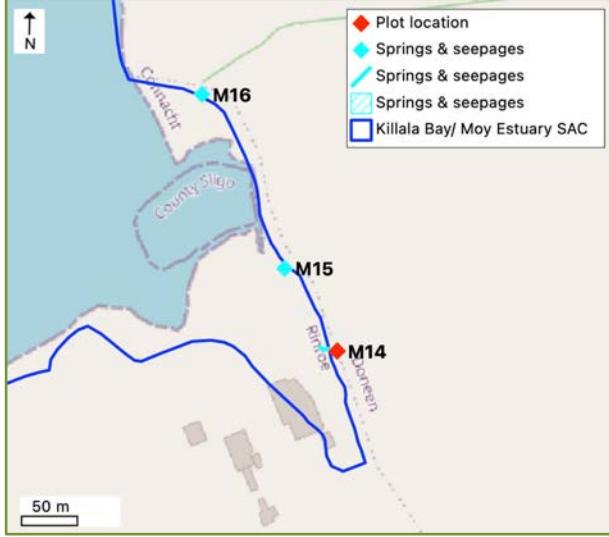
The vegetation has most affinity to Group 4 Palustriella commutata-Agrostis stolonifera Springheads vegetation community (Lyons & Kelly, 2017).		
Relevé location: The relevé (Figure 7.1; Photograph 7.1) is located below the path through Warren Walk Woods.		
Figure 7.1. Relevé location (M01)

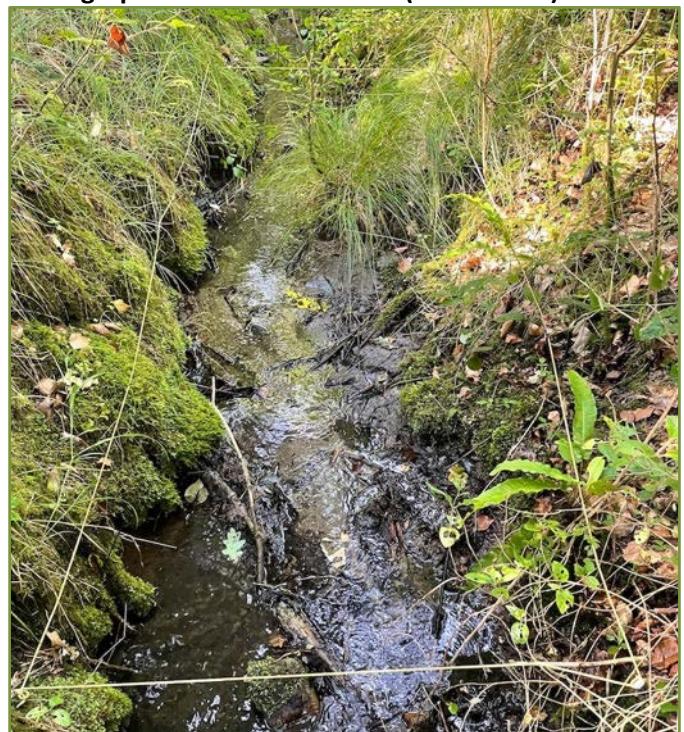
Photograph 8.1. Relevé location (view to SW)

The relevé (Figure 8.1; Photograph 8.1) is located in the middle section of spring M18. This spring originates in the southeast of the site and flows northeast to join M06 (Figure 3.1)

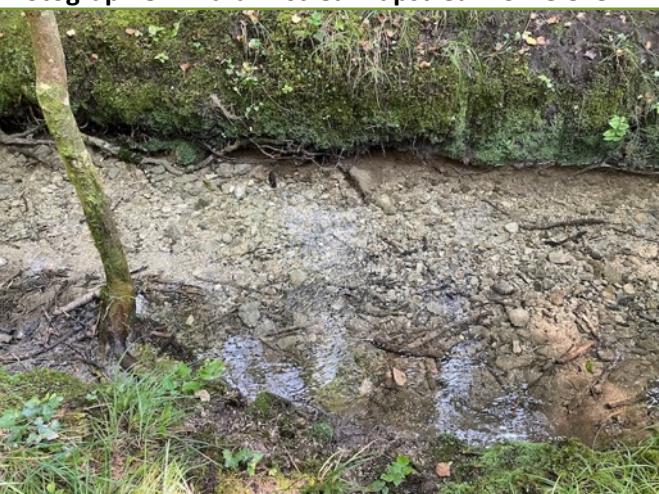
<p>Photograph 8.2. Tufa in stream upstream of relevé</p>

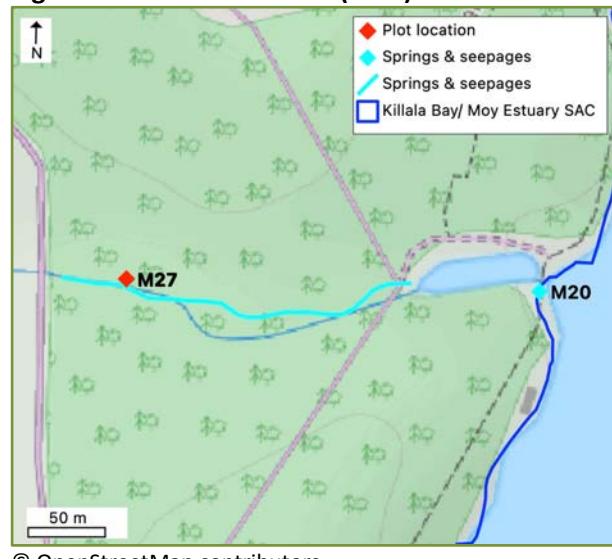
Figure 9.1. Relevé location (M27)

The relevé (Figure 9.1; Photograph 9.1) is located ca. 30m west (downstream) of the coast road

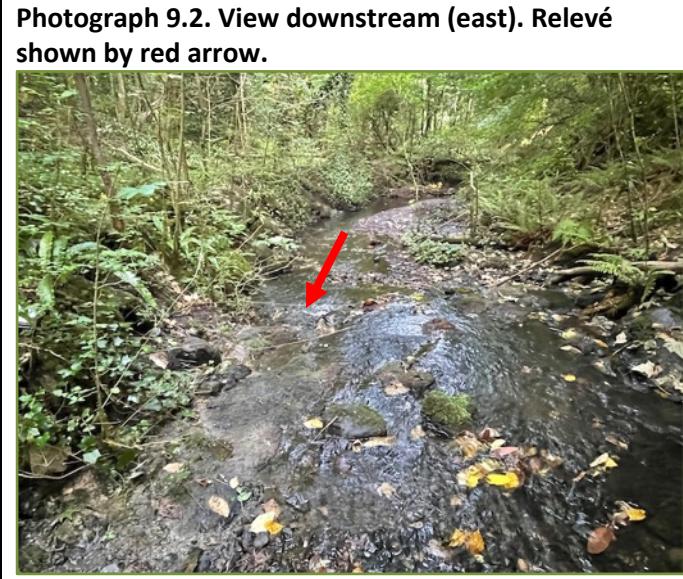
<p>Photograph 9.2. View downstream (east). Relevé shown by red arrow.</p>

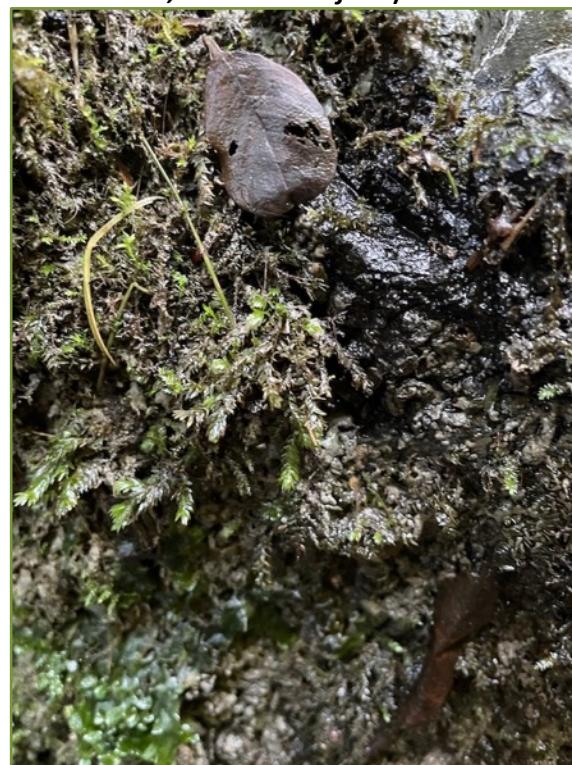
<p>Photograph 9.3. Vegetation within relevé (<i>Fissidens adianthoides</i>, <i>Pellia endiviifolia</i>)</p>

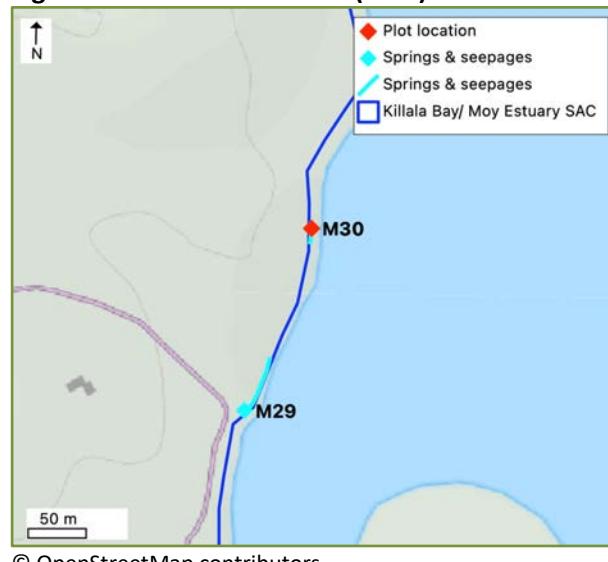
Figure 10.1. Relevé location (M30)

The relevé (Figure 10.1; Photograph 10.1) is located in the northern seepage section.

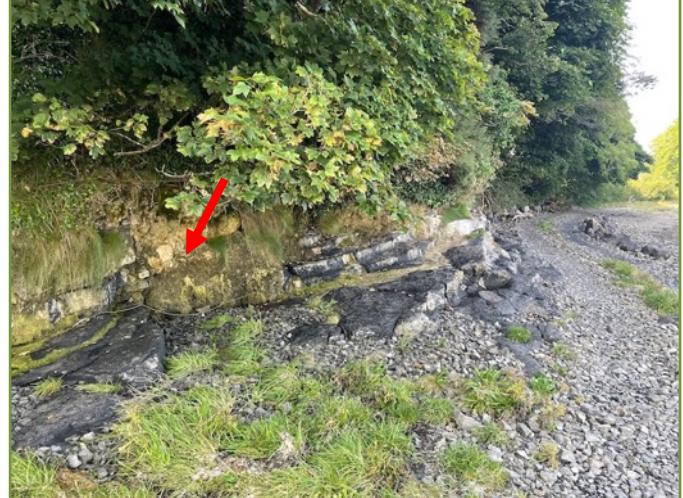
<p>Photograph 1.2. View north along estuary shoreline. Relevé shown by red arrow.</p>

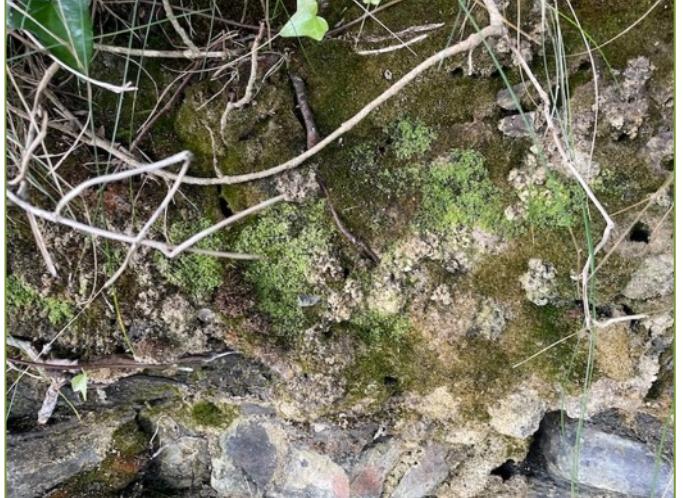
<p>Photograph 1.3. Vegetation within relevé (<i>Pellia endiviifolia</i>, <i>Didymodon tophaceus</i> and <i>Eucladium verticillatum</i>)</p>
