SISTERS OF MERCY CONVENT, BALLINA, CO. MAYO

**ARCHITECTURAL HERITAGE IMPACT ASSESSMENT and
CONSERVATION REPORT**

REVISION A - ADDENDUM ADDED - JULY 2024

**ADDENDUM - JULY 2024: TENDER FOR HISTORIC STRUCTURES FUND (HSF)
WORKS: SPECIFICATION AND DRAWINGS**

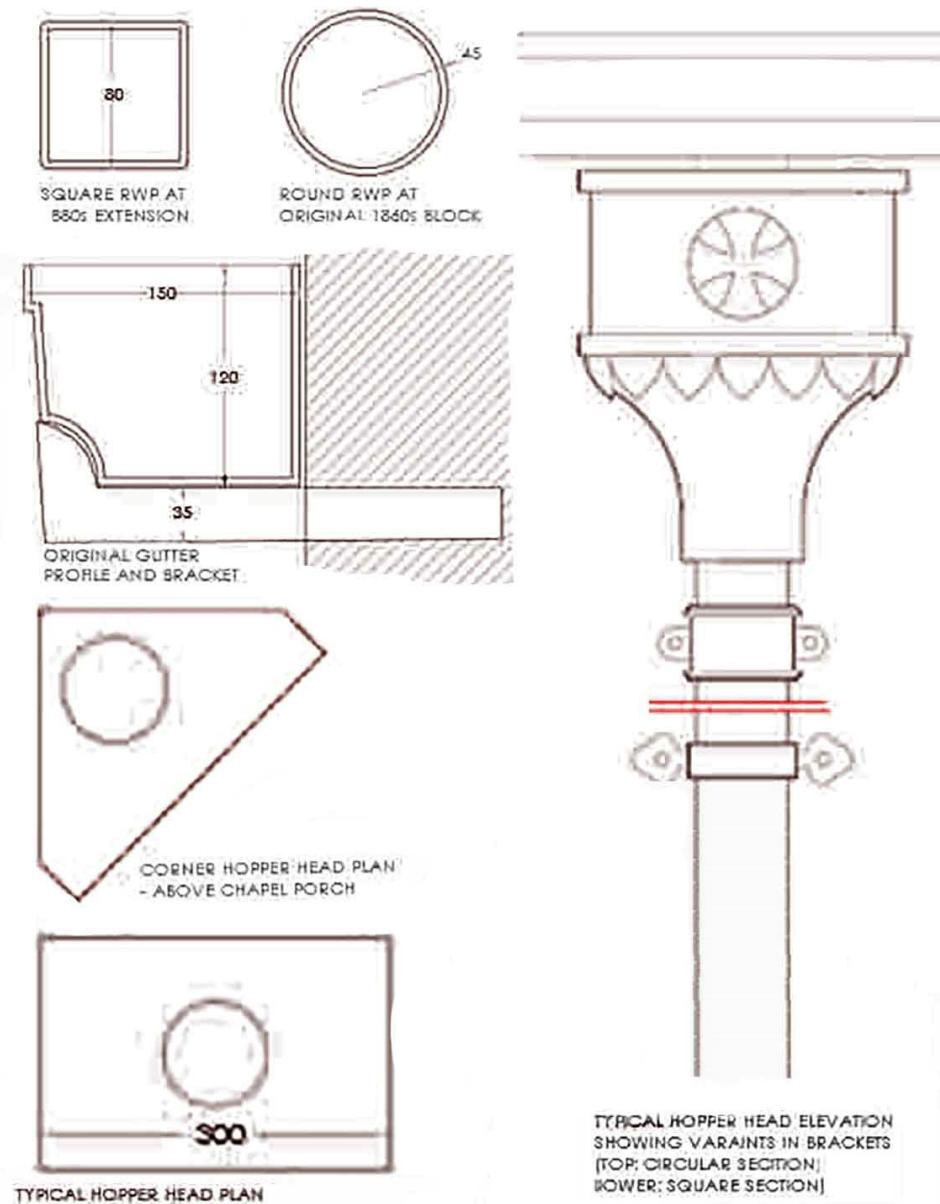
Existing Rainwater Gear Details

The cast iron gutters were almost completely replaced with aluminium seamless gutters in the 1980s. Some new aluminium downpipes were also added. Small sections of original ogee shaped cast-iron gutters, surviving at the exterior of the chapel apse and the side entrance porch to the chapel. The original gutters on the Apse are supported by stone corbels. These small sections, totalling 15m run in 4 no. segments (see drawings below) are wider than the seamless gutters. The gutters are a simple ogee shape with a flat cast iron bracket cantilevered from the wall. Approximately 50% of the original brackets have survived.

Surviving downpipe collars in fair condition generally.

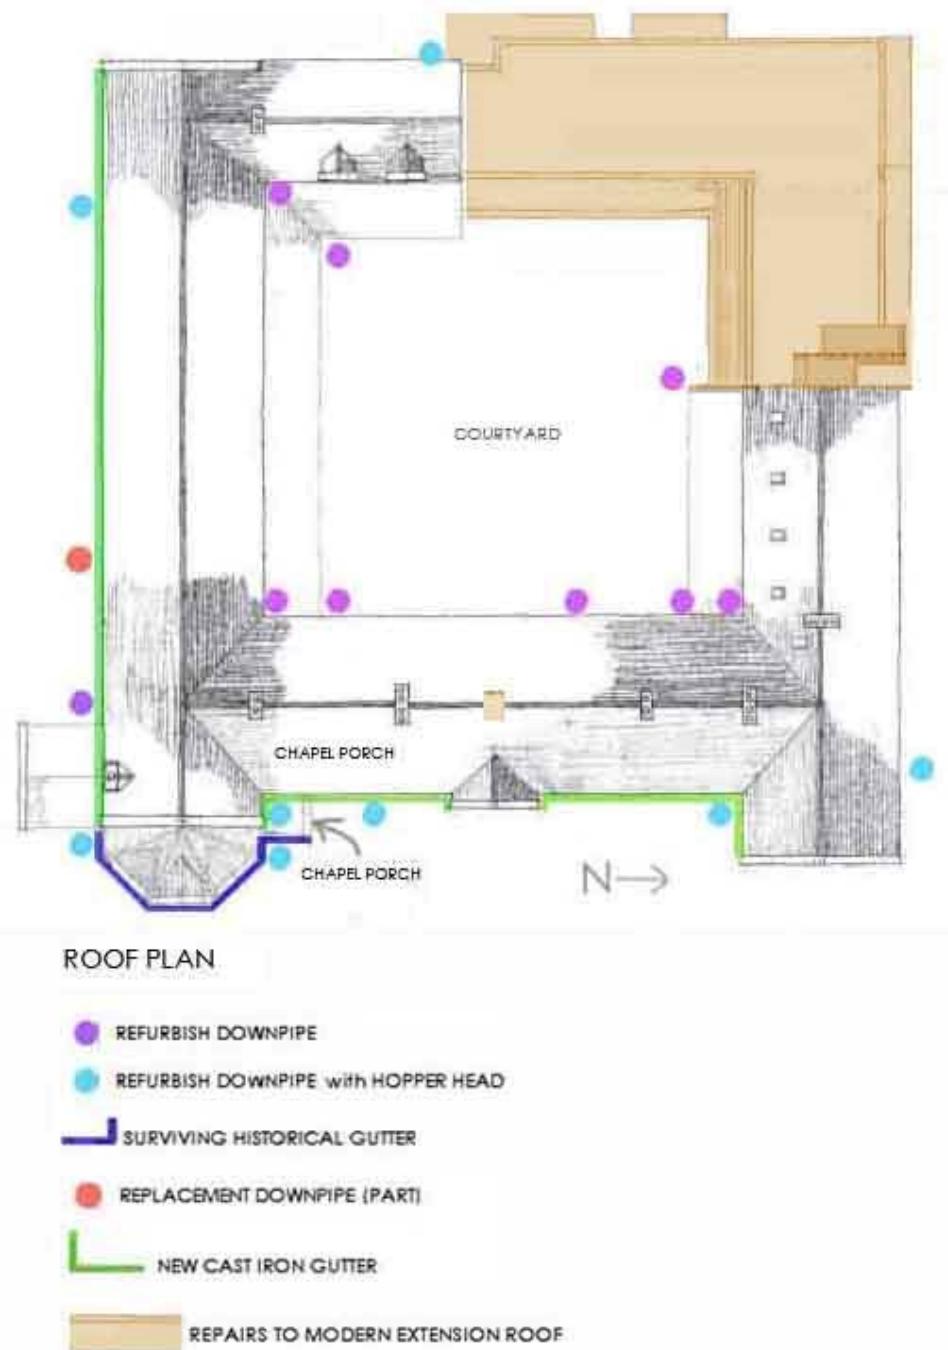
■ SEVERE WATER INGRESS

Details of existing cast-iron rainwater gear and plans of building below (using plans from *Martin Henihan Thesis*), with areas of existing severe water ingress shown blue.

Most of the recent water ingress was due to overgrowth and cleaning and maintenance will arrest the problem. The short-term proposals however include for replacement of the seamless gutters with new cast iron gutters at the east elevation where the aluminium has severely denuded and most of the water ingress has occurred. Cleaning of this gutter is not sufficient to arrest water ingress.

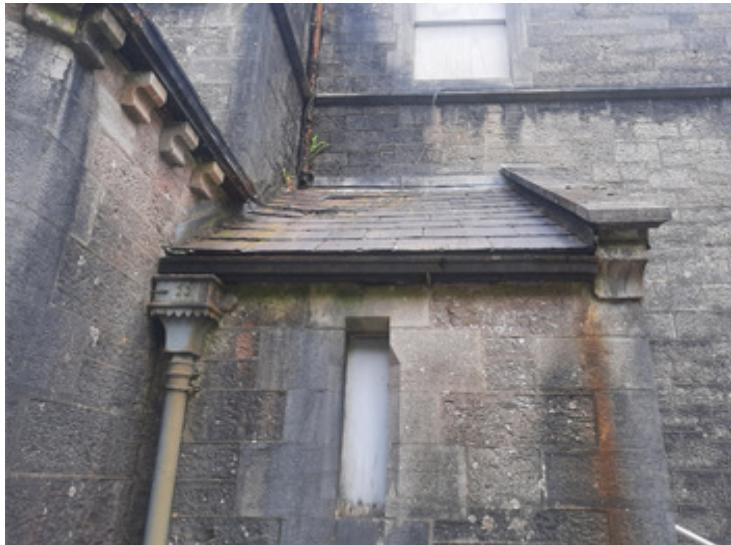
Close-up of damage at Chapel Porch Roof - section of surviving historic gutter also shown

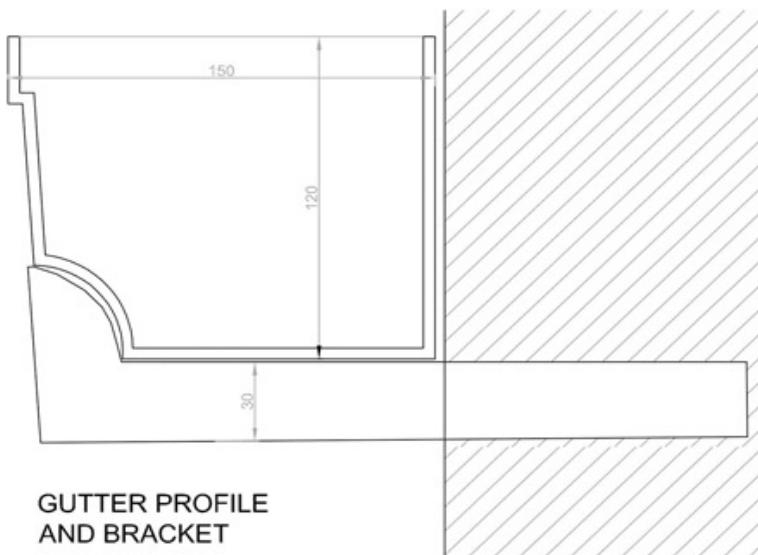
GUTTER PROFILE
AND BRACKET

Details of surviving historical gutters at chapel apse and chapel porch

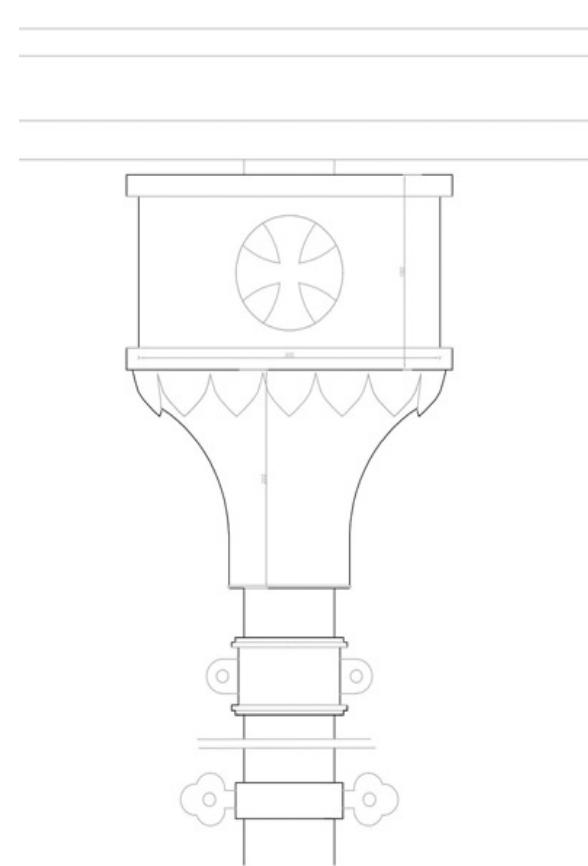
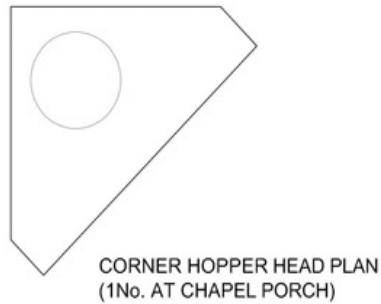
TYPICAL HOPPER HEAD ELEVATION
SHOWING VARIANT IN BRACKETS
(TOP: CIRCULAR SECTION / LOWER: SQUARE SECTION)

Details of surviving historical hopper heads
